Rubha Ghaisinis Sites and Updates

A number of new sites and features have been identified around the Rubha Ghaisinis, which formerly had only 8 listed sites. Most of the sites relate to kelping or fishing activities, but boats were routinely used by local residents as the road was not built until the 1990s, so trips to the Co-op, other shops, schools or friends were made on foot or by boat, hence the quay behind the Co-op (SCAPE site #14199) [as reported by a resident crofter.]

The Rubha Ghaisinis field project was prompted by undertaking a SCAPE Update on Site 8903, the Rubha Ghaisinis Chambered Cairn, when a chance find of an enriched mound with a bothan àirigh was identified – a position thought to be unusual

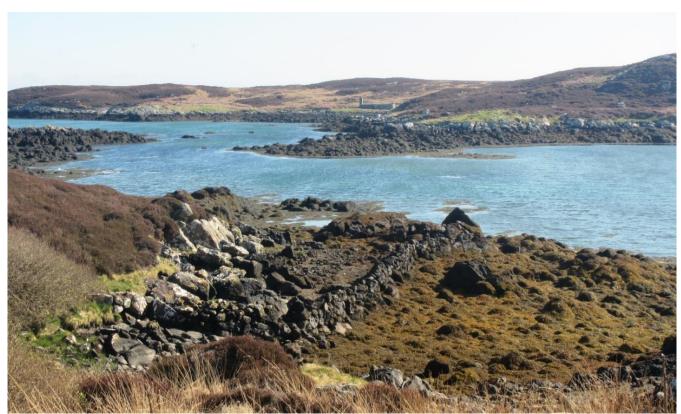
A second slipway/boat naust is extant to the south side of the headland at NF 81877 44661 where the footings are sited. It is of similar size and construction to that described for the west sited slipway/boat naust which sits at NF 81839 44712.

IMG_1187 The southern cleared slipway/boat naust found at NF 81877 44661 (site #001)

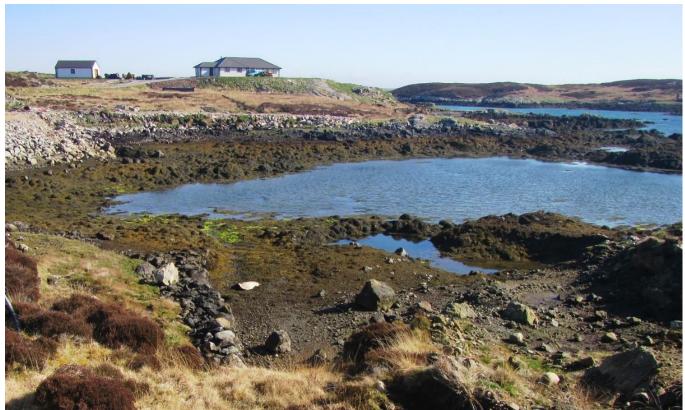
IMG_1188 the slipway/boat naust and stone quay to the western shoreline, northwest of the building ruins at NF 81839 44712. (feature #002) The large boulder at the top of the cleared area was probably used as a mooring bollard

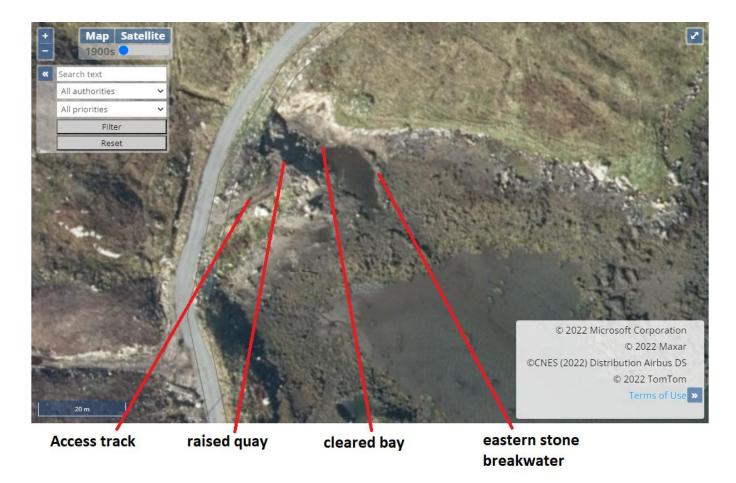
The satellite imagery provided by Microsoft/Bing clearly shows a cleared slipway/naust at NF81855 44799. The site has a short access track, from the main house driveway, which runs down to an apparent small stone quay. A secondary wall runs along the eastern side of the inlet and into the bay to afford some protection from wave damage during stormy weather. This site has been completely buried by the new landowner who has 'reclaimed' a portion of the bay with many tons of stone, broken concrete, sections of electric cabling and earth, probably demolition rubble, up to the level of the access driveway. This new reclamation can be seen on Canmore's satellite imagery, supplied by Bluesky International Ltd and Getmapping Plc 2020. Since the Canmore image, the landowner has continued with his civil engineering works and appears to be creating an encircling track around the property, mostly sited now just above the beach, but does affect the recorded features at SCAPE site #8899.

Image to left shows the 'original' features of the lost site, now lost forever, together with the enclosure boundary ridges visible on the shoreline to the north and east of the small bay/harbour.

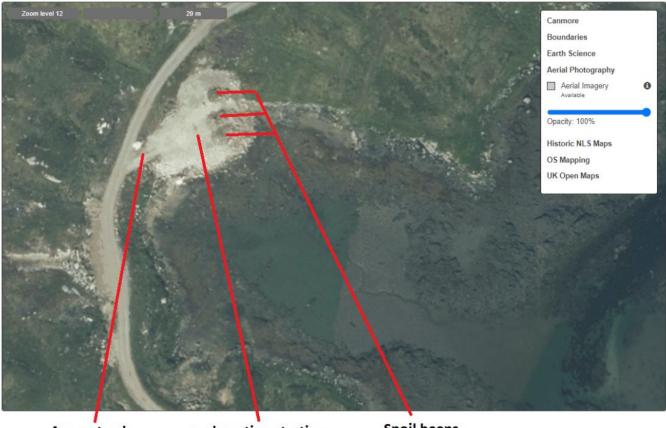
Access track reclamation starting

Spoil heaps awaiting spreading

Image of similar area taken from Canmore Mapping (©Bluesky International Ltd and Getmapping Plc), showing the reclamation activities underway. Each of the spoil heaps represents a dumped truckload of material, around 20-30 m³.

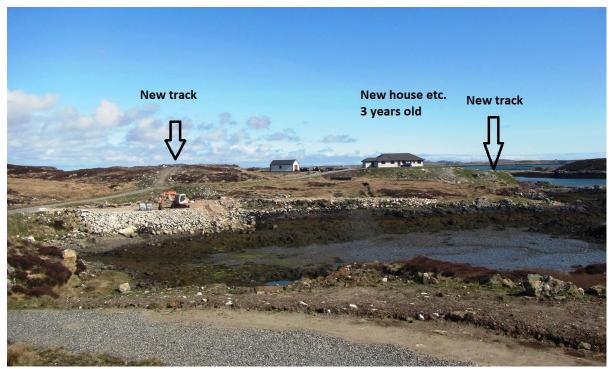
the new house now on the land and a view of the extensive and still ongoing groundworks which threaten some of the coastal archaeology, some of which has already disappeared!

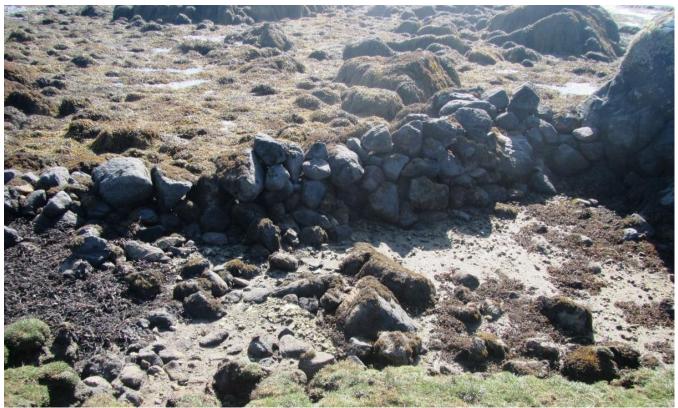
A drystone wall has been placed across a part of the upper beach at this point (NF 81952 44804) originally separating off a section of ground, which has subsequently been partly washed-out exposing shingle and boulders previously just above the high-water line. It is probable that this was a deposition point for cut tangle which would be piled here to drain before spreading on the local fields to dry prior to processing in a kelp kiln close to site #8899

IMG_1190 The wall to retain tangle whilst it drained, prior to drying on the adjacent fields.

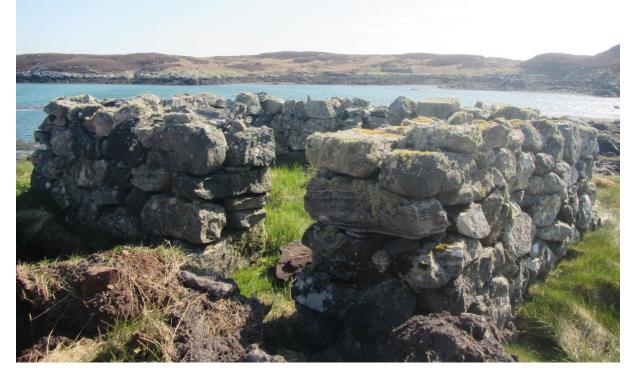
IMG_1193 the small drystone building just above the shore, probably a former kelp store.

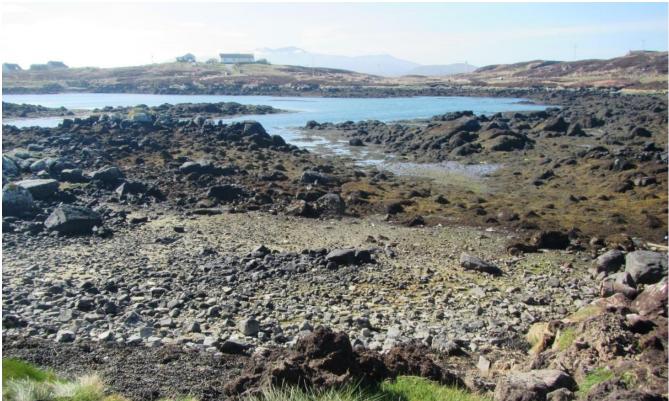
IMG_1190 cleared shingle beach (feature #005) adjacent to the building at site #8899, suitable for safe landing of boats to discharge tangle. A nearby bedrock shelf iss a likely place where kiln kiln was placed.

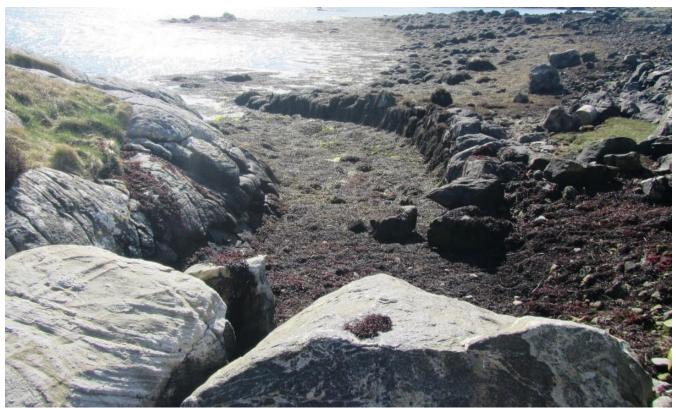
IMG_1195 Feature #006. At the north end of the beach at, NF 82008 44886, there is yet another boat naus common to find they do not run straight, so as to prevent waves entering tha channel directly with risk of damage to the boat within.

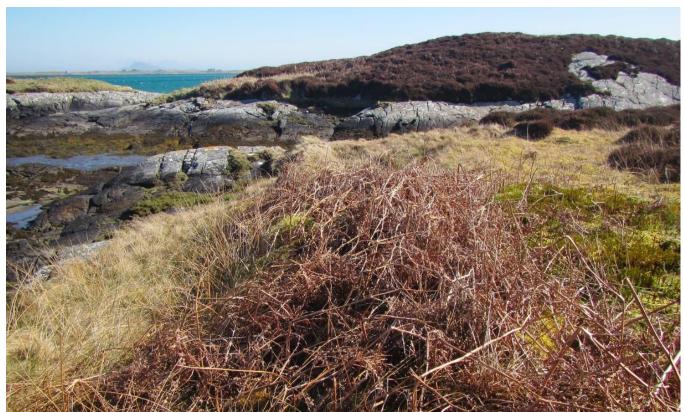
IMG_1206 The major boundary ridge demarcating the start of this kelping section at NF 81959 44948

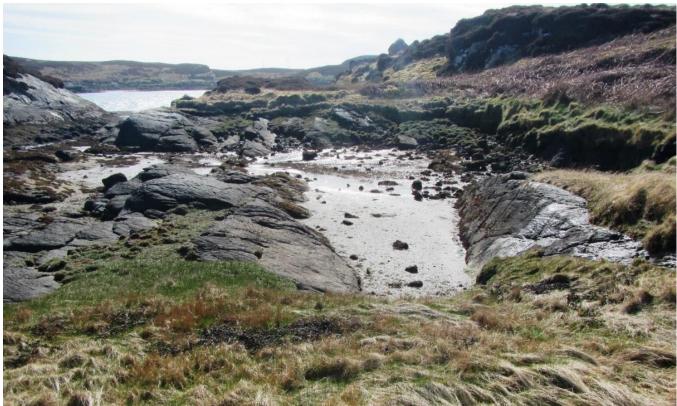
IMG_1208 A single boat naust, taking advantage of bedrock formation at NF 81951 44977

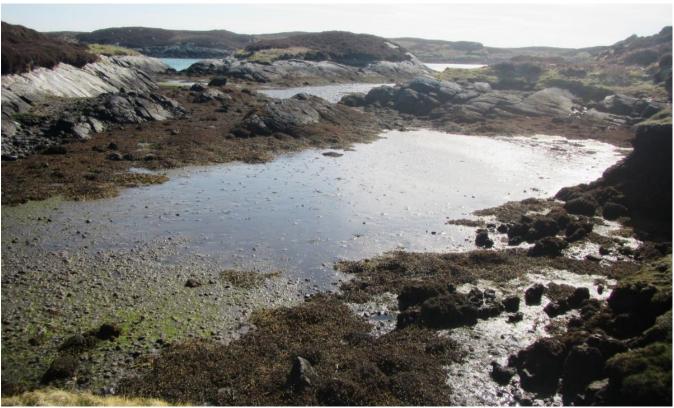
IMG_1209 the narrow cleared bay showing the protected access to the waters of the South Ford, as was probably a single farmer's allocation for kelp production

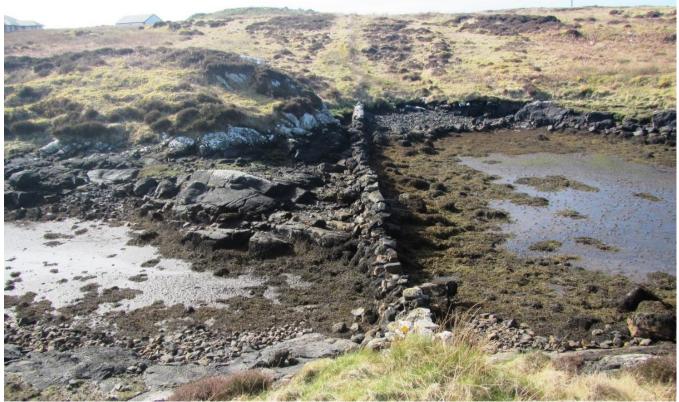
IMG_1217 the western bay, with its prominent boundary wall crossing the centre, and visible as boulder and turf ridges on both sides (feature #009)

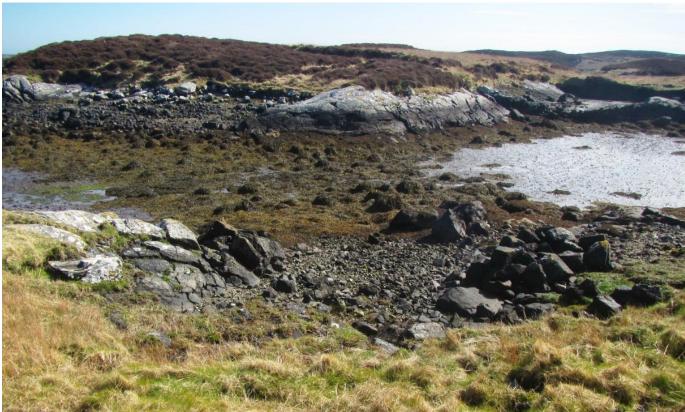
IMG_1221 Single boat naust feature #010 at NF 81838 45020

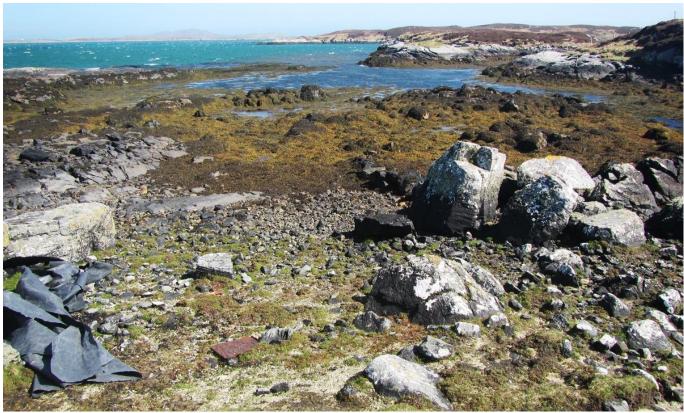
IMG_1175 Feature #011 another naust with adjacent line of boulders for tangle retention and draining

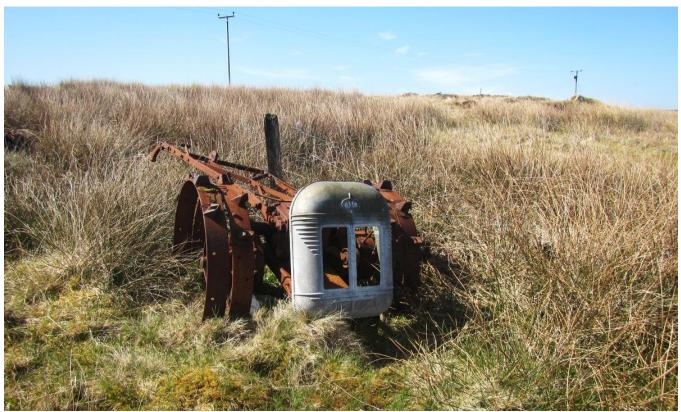
IMG_1176 Close to the site is this mid 20th Century motorised plough - a rusting dinosaur!

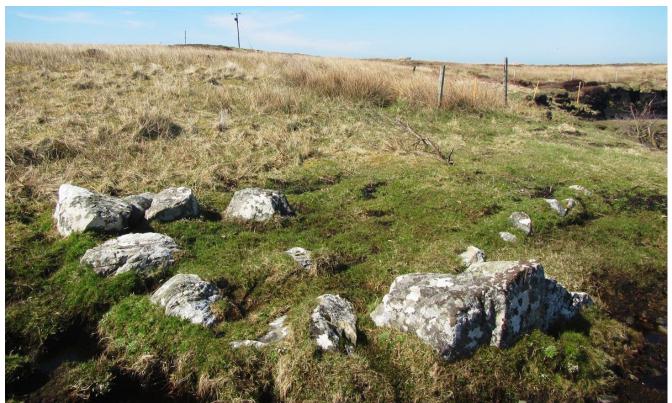
IMG_1174 Feature # 012 the remains of the stone setting, between features #011 and #013, probably the foundations of a turf storage clamp for finished Kelp product.

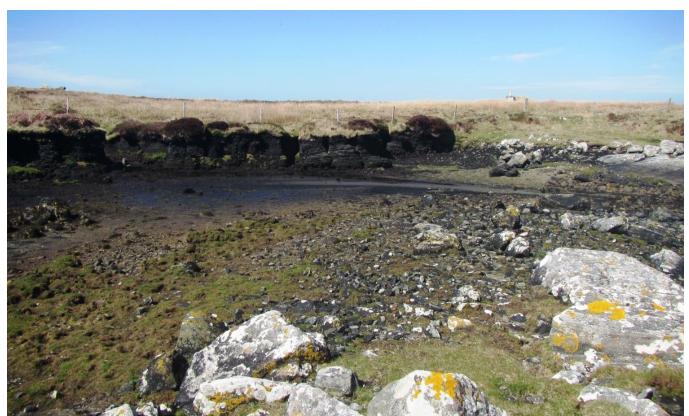
Feature #013 is a self-contained bay with steep peat banks on the shoreline There are two obvious nausts with adjacent kelp draining areas, and a cleared 'channel to the open water which would help get boats into the bay at mid tide.

IMG_1172 Feature #013, the self-contained peat backed bay with multiple nausts and tangle draining areas.

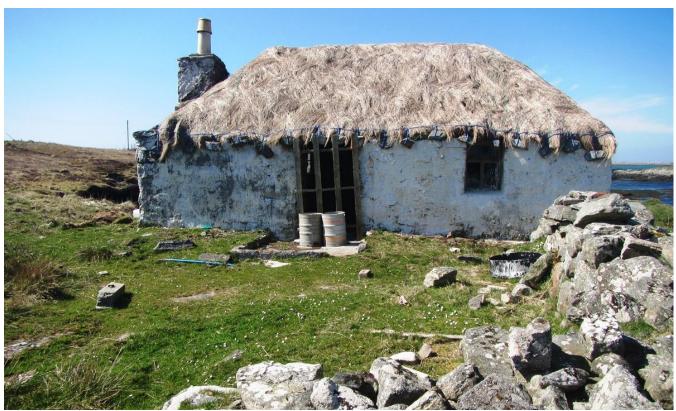
Aesthetically, this is an extremely attractive cottage, with thatch and lime-wash in good repair. However, the small porch referred to in the original entry has been removed, leaving only the flooring. Whether this was by design or storm is uncertain! Although it is in such good aesthetic condition, the cottage is currently used only as an animal food store and part time byre by the crofter.

IMG_1169 Site #8900 - idyllic from a distance! Front 'door' is a long pallet held in place with two otherwise redundant barrels.

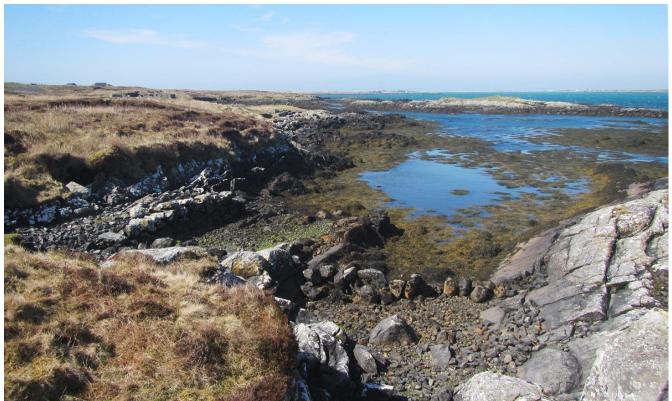
IMG_1166 Feature #015, the boat slipway/naust (left) and adjacent tangle draining area, above the line of boulders (right) at NF 81684 45203

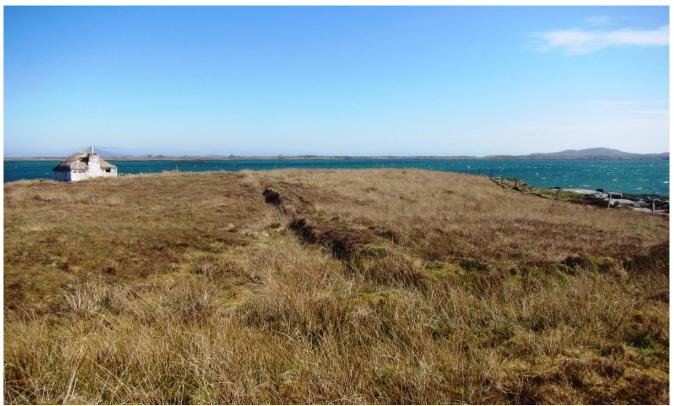
IMG_1226 Feature #014, some of the field boulder-and-turf boundary ridges on the hinterland at NF 81699 45152, with the cottage (site #8900) behind.

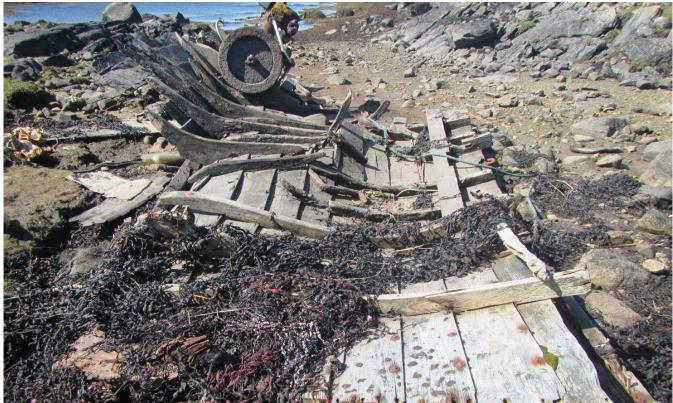
IMG_1160 Old wooden boat still occupies one of the boat nausts at feature #16, situated at NF 81559 45227

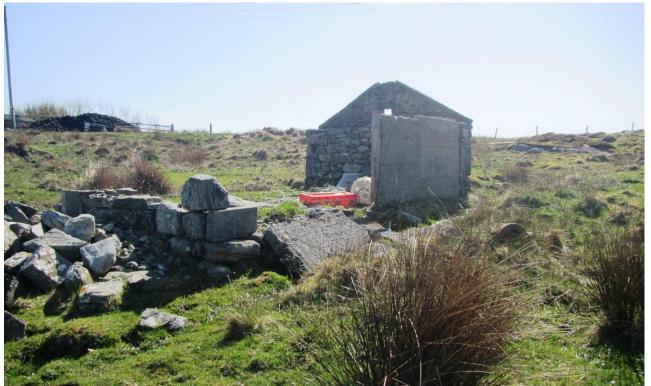
IMG_1156 Ruins of old croft house, now replaced but shown on early OS maps sited at NF 81515 45207

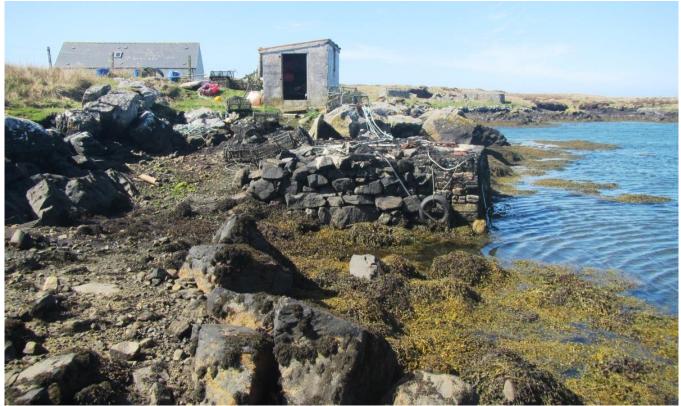
IMG_1158 Feature #017, a small shed and the substantial stone built quay for boat access at mid tide. The roof behind belongs to Crofthouse number 12 (now a holiday let property), with SCAPE Site #8901 just visible in the background

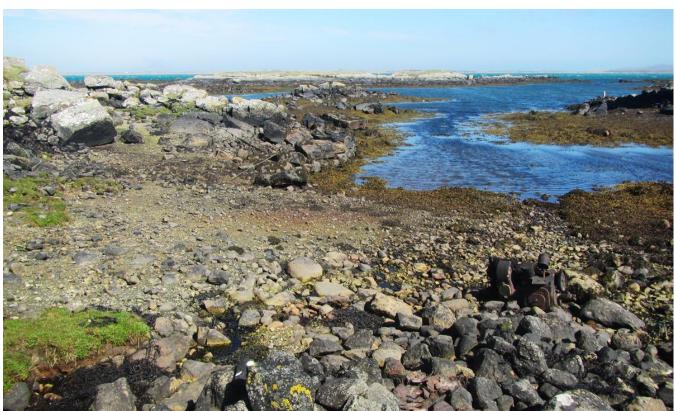
IMG_1155 Croft 12's cleared shoreline area for boat beaching, with an abandoned small marine engine.

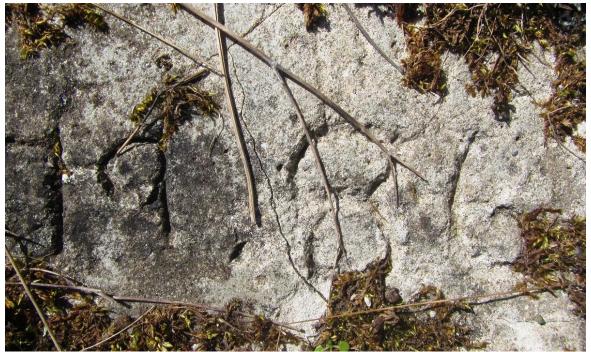
IMG_1151 "1986", as naively inscribed into the concrete draining platform of the sheep dip

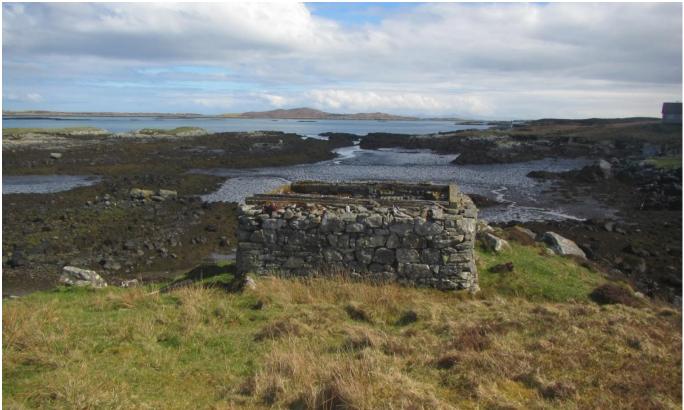
IMG_1018 The small 'shed', the easternmost building of the three at Site 8901. Similar size sheds were used for storage of Kelp product storage.

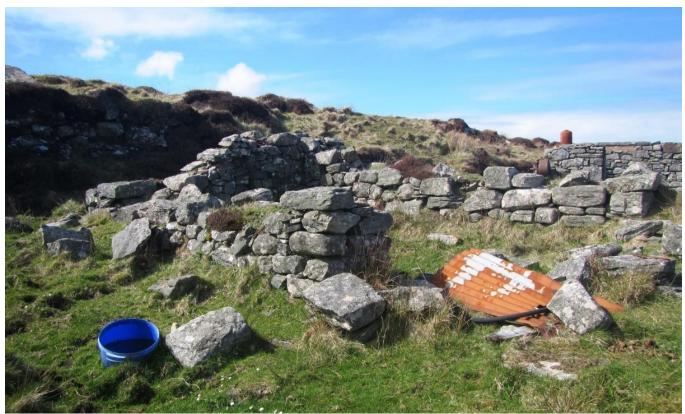
IMG_1021 The ruins of the central building at Site 8901, likely to have been a small byre originally.

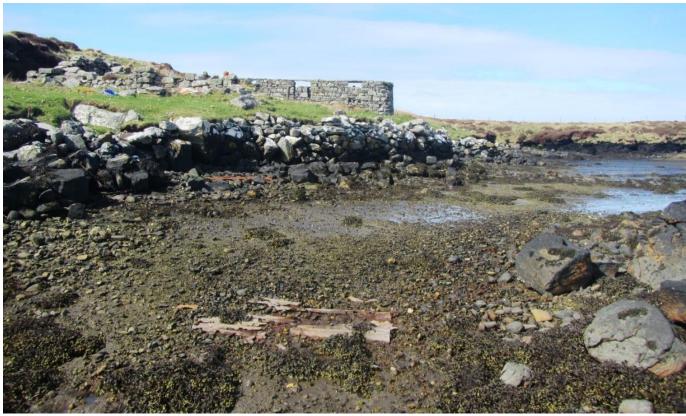
IMG_1027 The revetted quay and extensive cleared bay at Site 8901

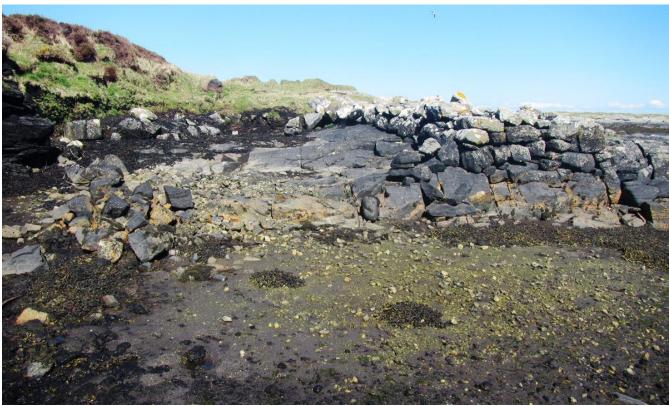
IMG_1076 Retaining wall, breakwater and naust at the western extremity of Site 8901's bay at NF 81409 45340 (feature #019)

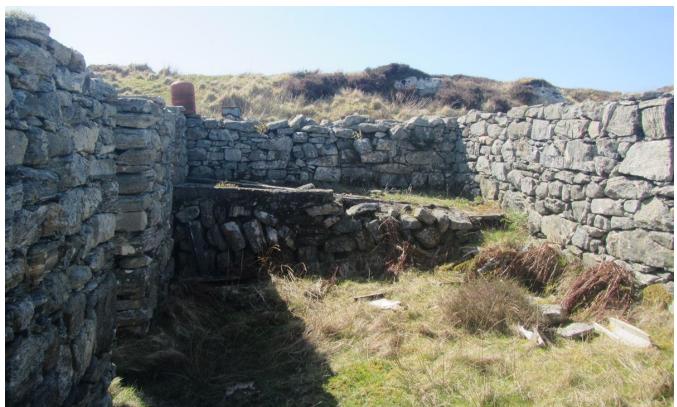
IMG_1154 The interior of the house, looking south, showing the draining platform of the sheep dip. The dip tank was against the west wall (right) but has since collaposed, probably from frost damage.

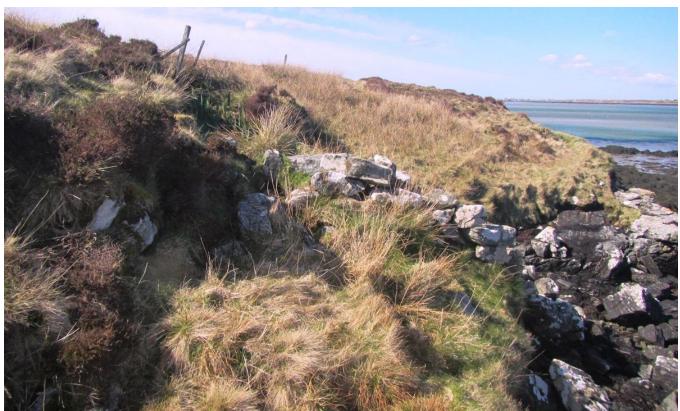
IMG_1081 Feature #020, the maritime end of the significant property boundary wall

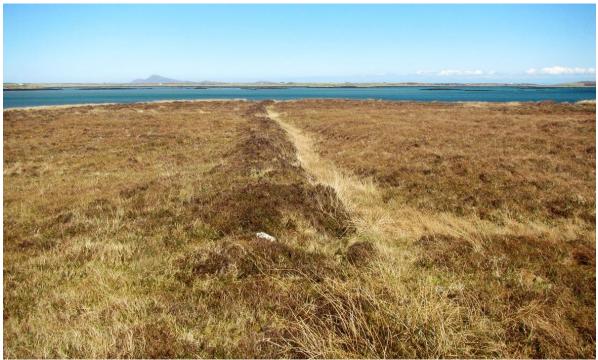
IMG_1075 The boulder-and-turf ridge and ditch boundary crossing the hinterland

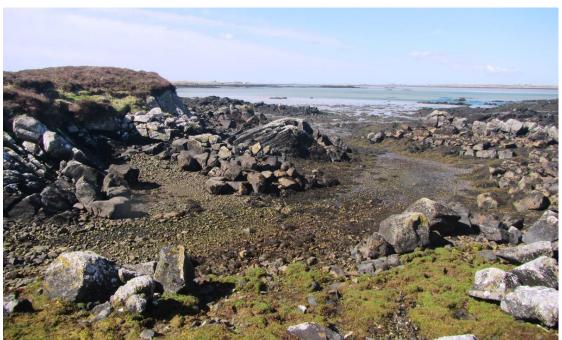
IMG_1088 The track snakes its way between boulders and bedrock from the shoreline to the open sea of the ford. Note the sheltered naust on the left with its opening facing the shore to give guaranteed safety from all but the worst weather

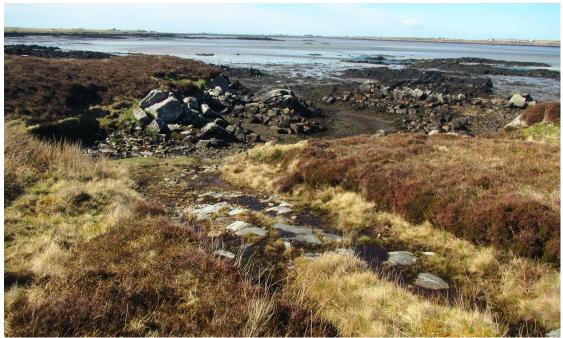
IMG_1103 The lower end of the track heading across the hinterland to the shore

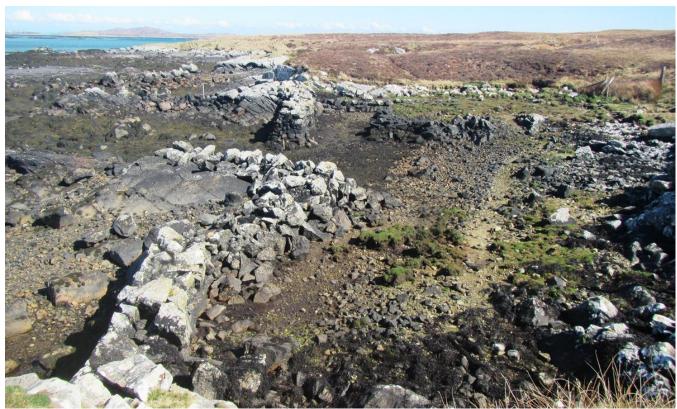
IMG_1095 Looking across the harbour from the west

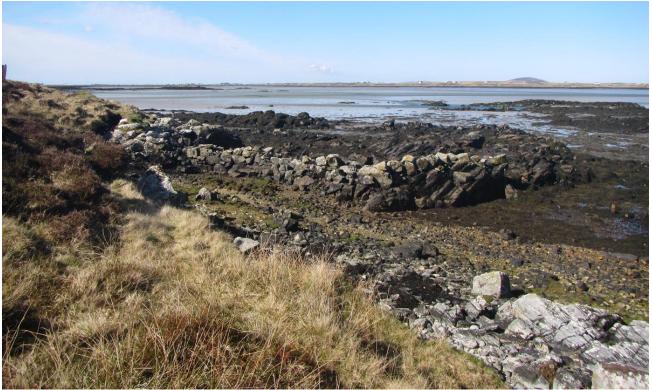
IMG_1099 The western wall of the harbour with its naust. The bedrock in the right foreground could be used as a kiln site.

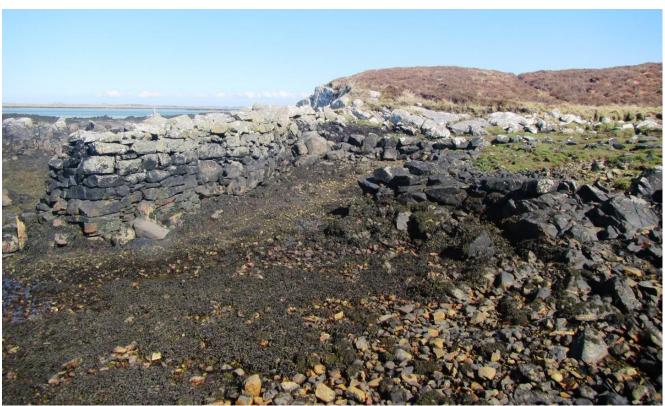
IMG_1098 The substantial east wall of the harbour with a naust immediately alongside. The raised green area with its fringing boulders would be ideal for tangle draining.

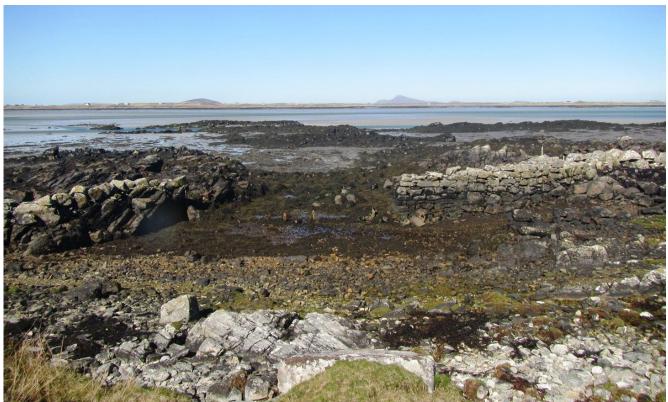
IMG_1101 the harbour viewed from the south, the hills of Ruabhal (Benbecula) and Eabhal (North Uist) in the distance

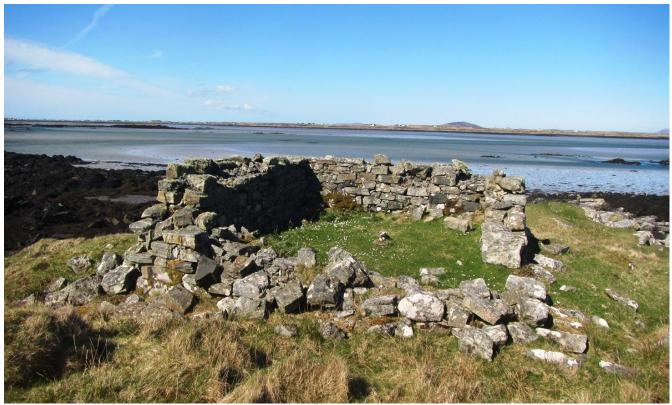
IMG_1093 The smaller building at site 8902, typical of a small byre of the time and locality

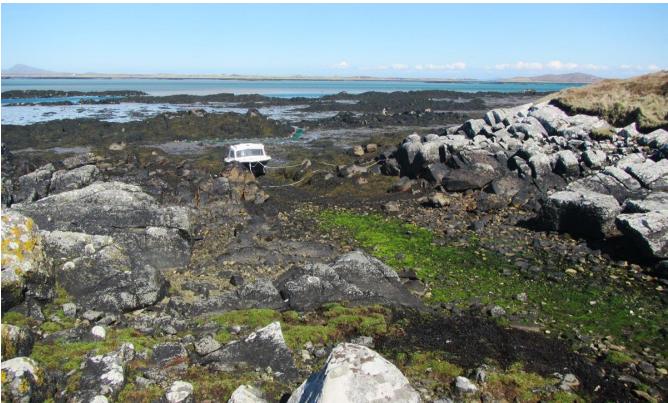
IMG_1090 The eastern slipway and naust – in use today by a local fisherman collecting tangle for commercial animal feed factory.

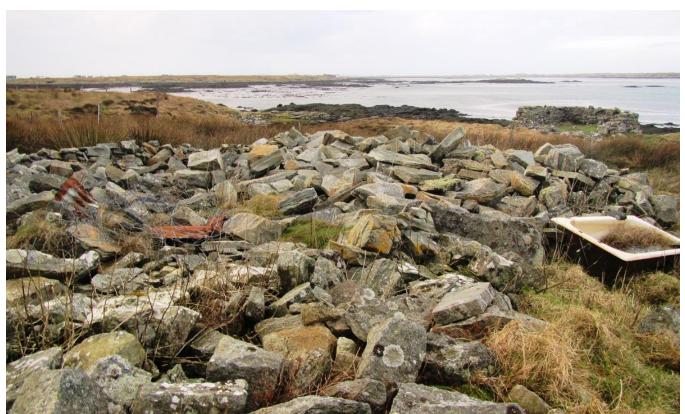
IMG_0378 The wreckage of the larger building, complete with its bathtub!

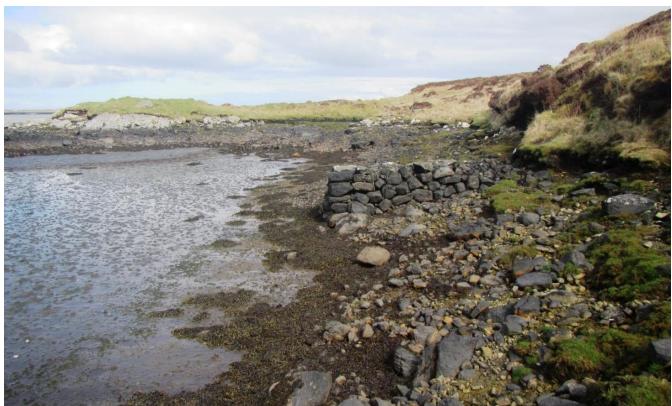
IMG_1062 The jetty (feature #025) in the centre of the sheltered bay, looking north east

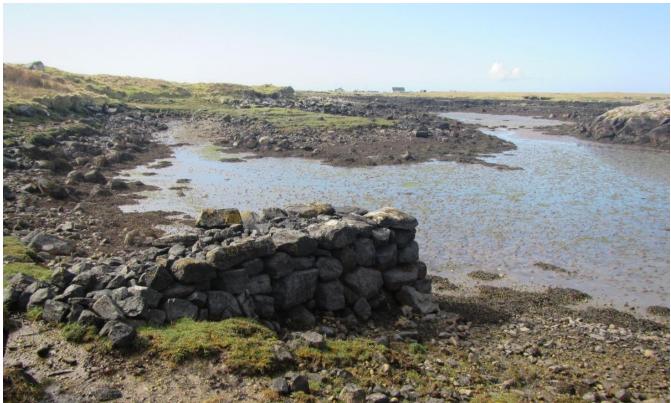
IMG_1064 Looking south west over the jetty to the kelping complex with its grassed drying area and small turf walled bothy on the promontary.

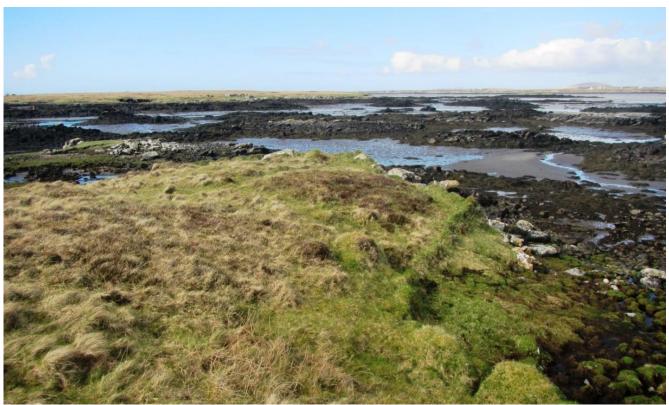
IMG_1065 Looking down the promontary towards the remains of the turf walled bothy (feature #025) at the end

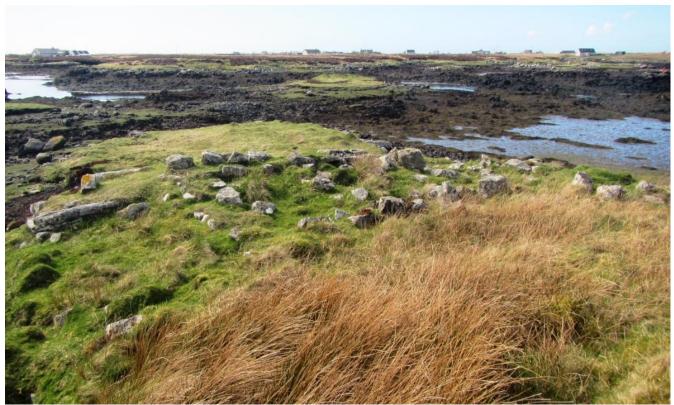
IMG_1066 Site 8904 looking west across the site - little more that the footings and some tumble remains.

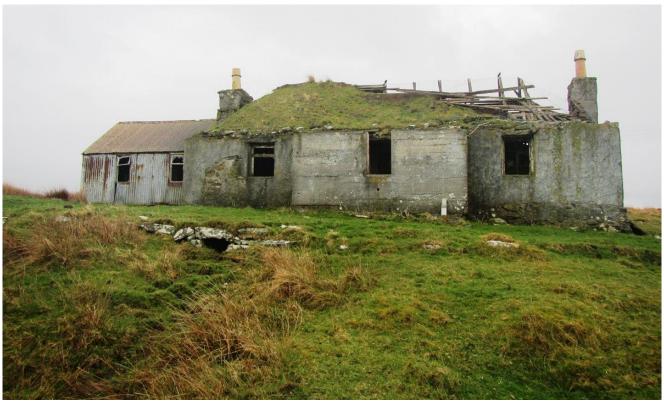
IMG_0989 The extended cottage (feature #026) just above the byre at site 8905. The small stone bridge is a channelled stream which once flowed where the corrugated iron extension now stands

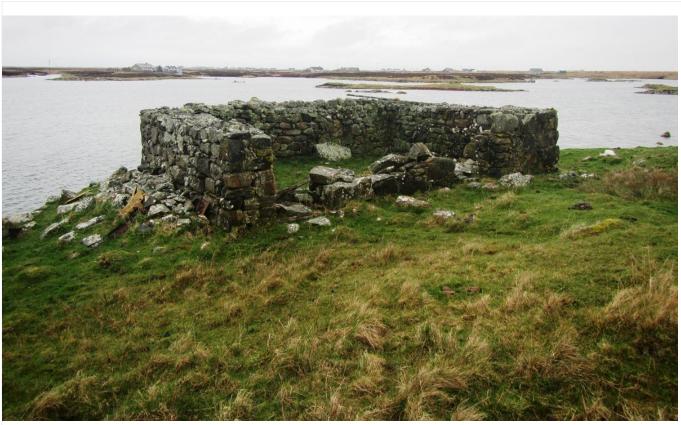
IMG_0990 The byre at site 8905, once twin doored, but the front wall, as viewed, has collapsed.

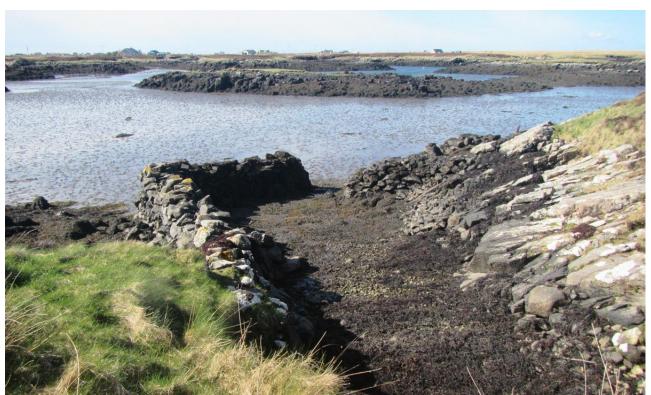
IMG_1105 The southern slipway/naust curving down to the bay (feature #028

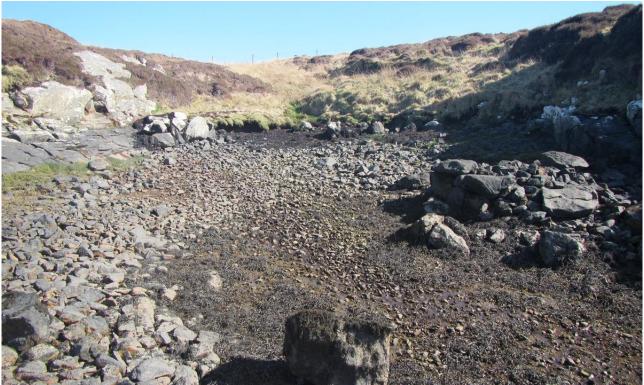
IMG_1110 The northern landing area is wider and has a rudimentary quay for off-loading, however it is also rather more exposed (feature #027)

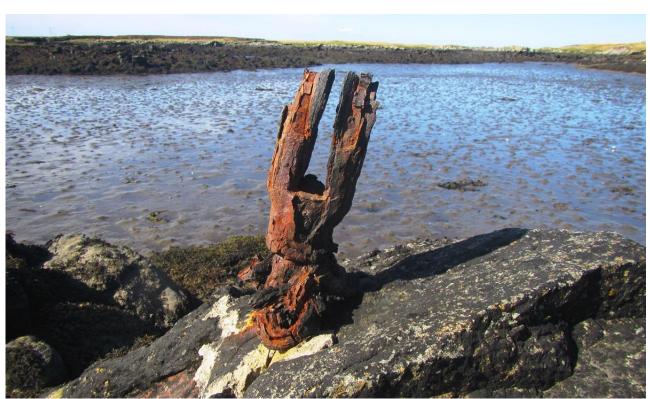
IMG_1107 - the iron bracket mounted in the headland's bedrock, possibly for a lantern mounting

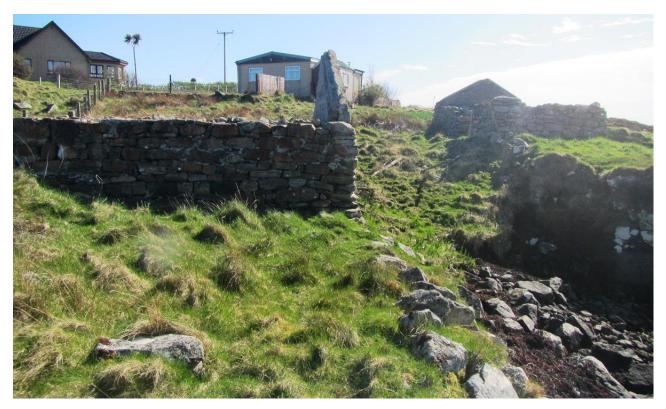
IMG_1112 The two ruined dry-stone built huts with the cabin style holiday home behind. The croft-house is just visible top left

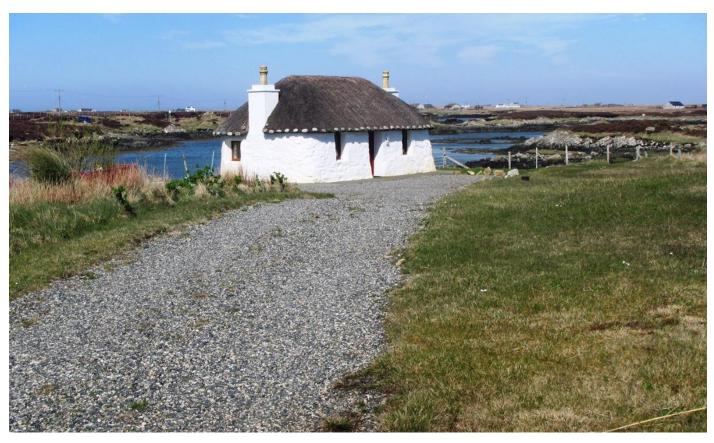
IMG_1149 The restored thatched cottage, now a holiday home

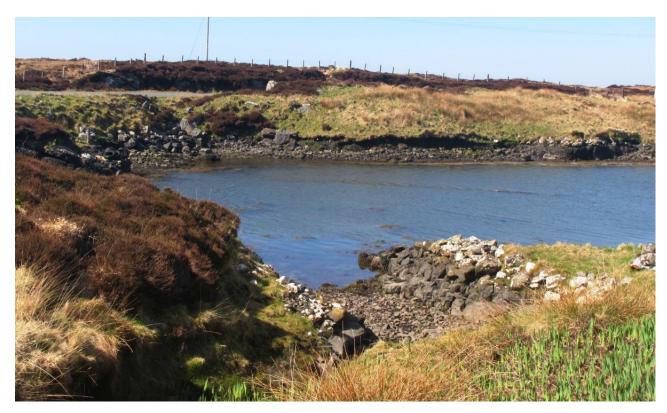
IMG_1149 The slipway/naust to the south of the thatched cottage at mid tide

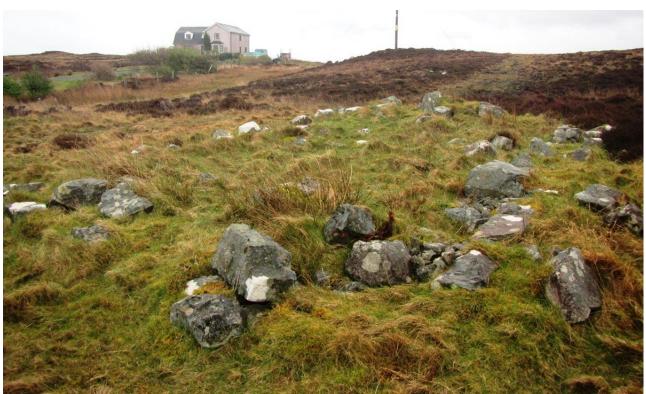
IMG_1001 the remaining stone foundations of the former cottage, south tip of Grosavagh

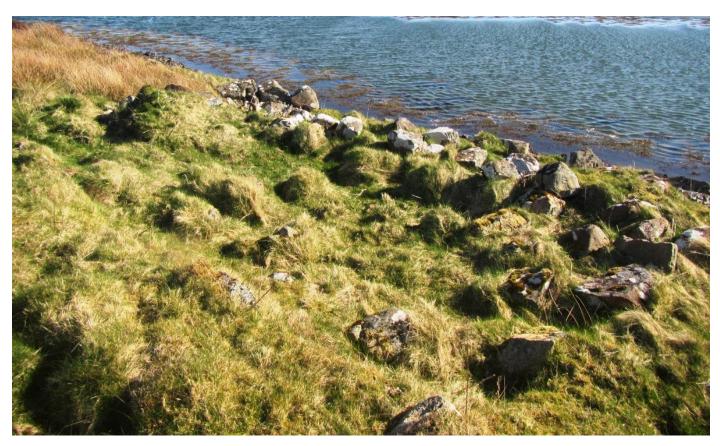
IMG_1121 Feature #034 Foundation remains at NF 80450 45039

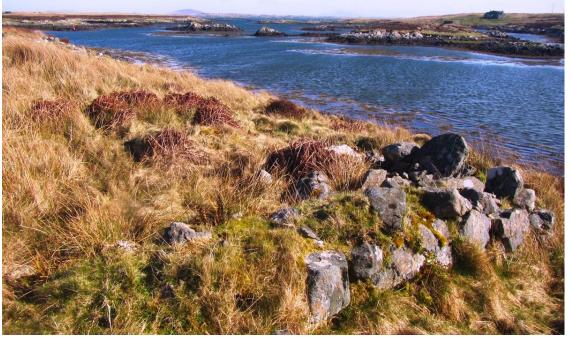
IMG_1124 Feature #034

Between the road and the inlet called Grosavagh, thwere is a narrow strip of rough grassland. Within this there are the foundation remains of a number of small houses and buildings, which appear on the 2^{nd} Edition 6-inch OS map
