An Archaeological Survey  
of the townships of Glame, Manish More, Brochel  
and the farmsteads of Doire Domhain plus a field  
survey of the surrounding area.

# Raasay

## Brochel Castle

Occasional Paper No.26

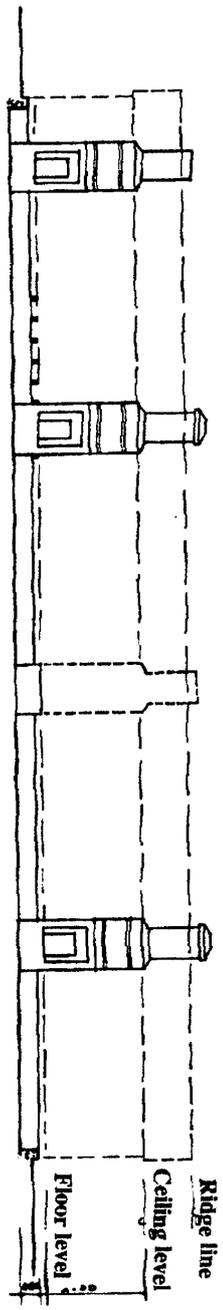
West elevation

They are however the remains of a lineal group of four bothies which went out of use in the late 1920's. Three chimneys still stand and one has fallen. All the remaining structures are out of plumb and are in a dangerous condition.

The in situ cast concrete under building measures 29.50m long by 4.00m wide externally and are 0.225m thick and at least 0.6m deep. From the remains it is clear that the building was a simple timber frame structure of 100mm x .50mm wall studs with 175mm by .50mm floor joists at 600mm centres. The flooring was tongue and groove board while the walls were clad similarly. Externally the walls and roof were clad with galvanised corrugated iron sheeting. Four doors gave access to the units and there is evidence of windows.

Floor: Tongued and grooved flooring  
22 mm on 175 x 75 mm joists at 600 mm centres.

Roof: Corrugated iron sheeting on purlins and timber couples.

Walls: Corrugated iron sheet cladding on timber stud walling, 100 x 50 mm rails and studs finished internally with tongued and grooved boarding.

Underbuildings: In situ cast concrete ring beam underbuildings, 225 mm thick by 600 mm deep.

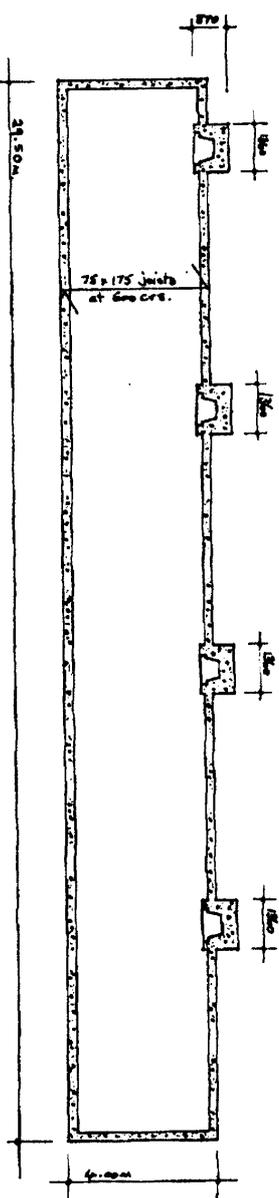
Plan

From the arrangement of the flues and their spacing it is likely that the southern-most unit was larger than the other three and may well have had a separate bedroom. The other three appear to have been single apartment dwellings. There is no evidence of any internal toilet arrangements nor is there an obvious external toilet structure or trench.

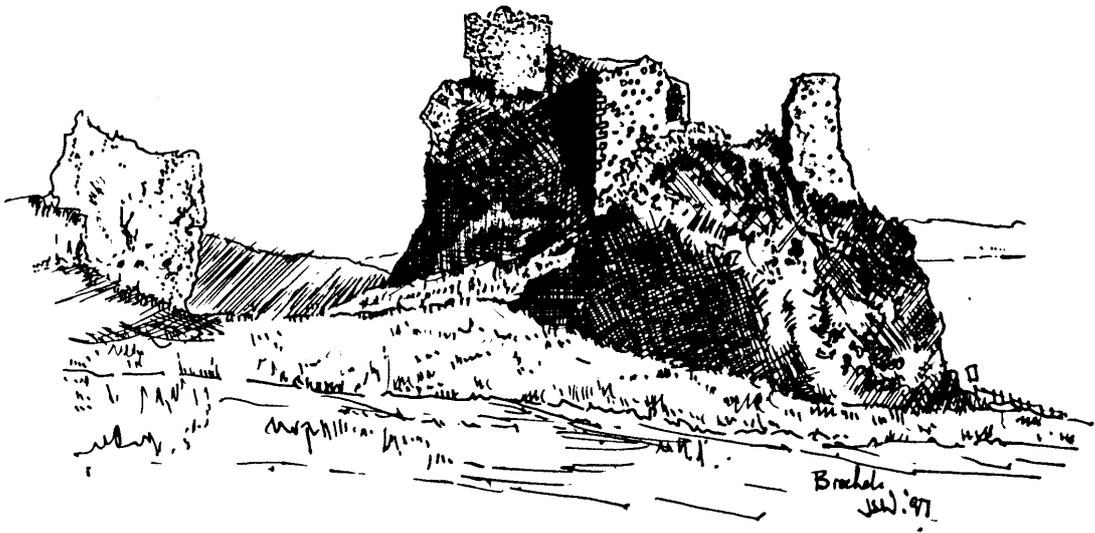
**Brochel Castle**

The castle at Brochel is perched on the summit of an isolated agglomerate stack of Torridon grit and sandstone occurring in a small bay set among the cliffs forming the northern part of the east coast of the Island. To the north the view is closed by rising ground but the outlook to the east is an uninterrupted prospect of the hills of Ross-shire.

The castle rock stands some 15 metres above the adjoining land. The summit is in two levels some 6m one above the other, with the building occupying both.

The entire rock is fenced off, with prominent signs warning of danger and prohibiting entrance. A cautious and limited incursion was made to determine the extent of the remains and any changes from the details shown in the Inverness-shire Inventory dated 17th June, 1921.

Although the stone work is in a very poor and dangerous condition, there have been no major collapses. Indeed, there was no obvious evidence of any changes having taken place during the past seventy-five years.

No attempt was made to reach the higher levels and a plan of the lower level was prepared from observation made and with the aid of the published plan.

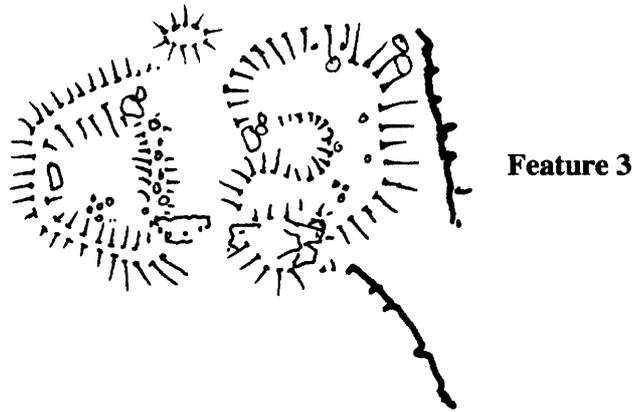
Feature 3 is the remains of a sub rectangular structure 23m south of the castle rock. It lies east to west, measuring 8m by 3m internally.

The east end contains what appears to be a kiln bowl, 1.7m by 2.2m and 0.1m deep. The interior of the bowl is flat and turf covered. The rim of the bowl is quite well defined, with stones protruding through the turf. There is no trace of an outer face in the east part of the structure. The east end is rounded with stones, some earth fast and some loose, protruding from the turf. The structure is built against outcrop in the southeast quadrant.

There are openings in both the north and south sides that may be original entrances for opposed barn doors. The opening in the south wall is 1m wide and there are traces of a built stone face on the north interior side of the opening. There are also vestigial traces of walling, using small stones, on the west side of the opening. This walling is 0.7 m thick.

The opening on the north side is 2m wide with no trace of walling. Outside this entrance there is a hump 1m from the entrance lying parallel to the north wall. It is 2m long by 1m wide. No stone is visible in this hump, but it is in the correct position for a windbreak.

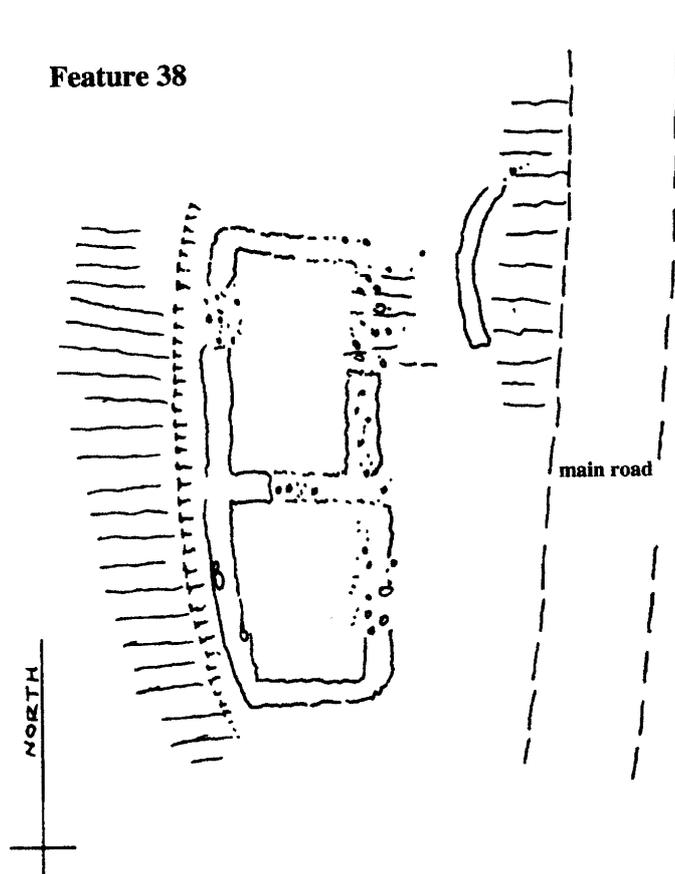
Feature 38

This feature was probably a fisherman's bothy.

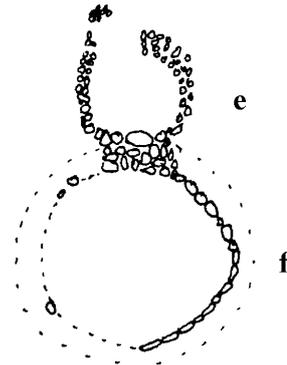
## Feature 14

On a flat area below a west facing, steep rocky slope, and just to the north of a deep ravine down to the Glam Burn, lies a collection of seven diverse structures. Our first thoughts were that we had stumbled on a prehistoric, possibly Neolithic, village. However, on more sober reflection, while some structures, such as the cairns, retain the potentiality of being Neolithic or Bronze Age, the round houses seem more likely to be a group of small structures of more recent construction. The rough nature of their construction made it impossible to determine the number of courses remaining standing. The structures are described in order, roughly north to south.

**D** On the western edge of the flat area, about 40m west of 14B, a group of upright stones, with the largest 0.6m high and 1m long, appears to form the north-east quadrant of a robbed-out kerb cairn. Several other, lower stones were found hidden, earthfast in the heather forming a round kerb 5m in diameter.
