Kyle Rona, Achadh and Doire Dubh

An Archaeological Survey
of the settlements and surrounding area at the North End of

Raasay

Association of Certificated Field Archaeologists
Occasional Paper No 90

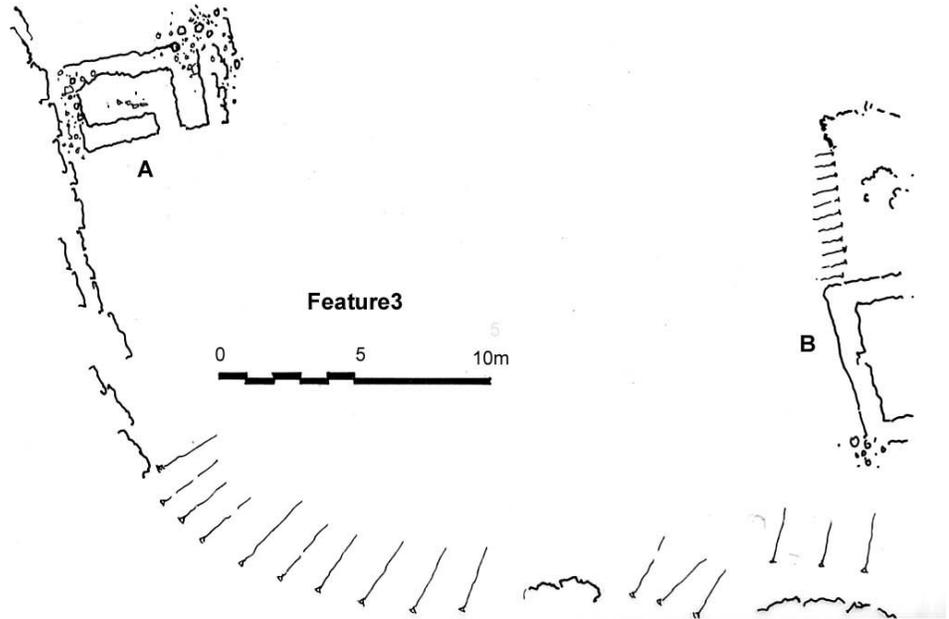
Feature3

Central on the ledge towards the southern rockface, Feature 3B (NG 6130 5189) is a larger sub-rectangular building, measuring 7.0m by 4.80m. Again with well squared corners the walls stand to a height of 1.30m, 0.80m thick. The structure is considerably the most tumbled of the three. There are no internal features or dividing walls in the building nor could the entrance be positively identified, but examination of the sparse remains indicated that it may have been in the centre of the east wall. Evidence was found that lime mortar has been used in places. To the north in front of the structure a large apron of bedrock has been revetted to form an area of hard-standing 6.0m by 5.0m. It seems likely that this building is a barn.

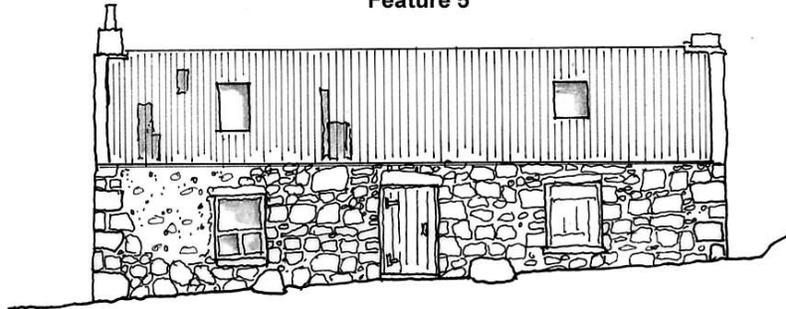
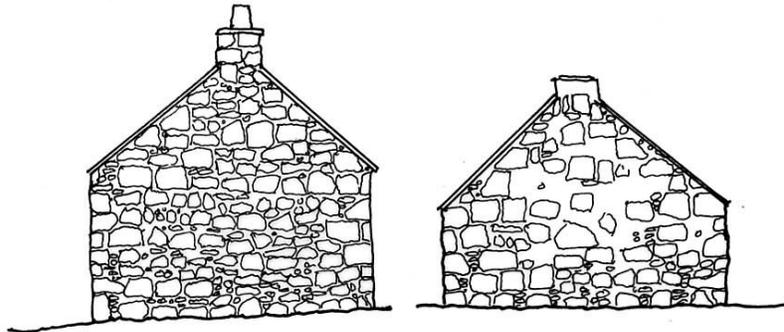
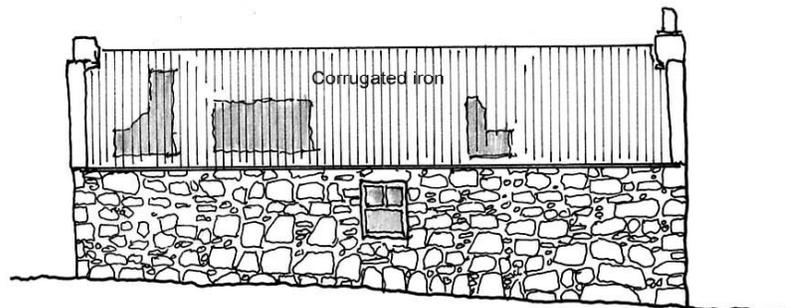
Feature 5

The back (northeast) wall, 11.70m long, stands to 2.20m at the south end to 2.70m at the north due to the variation in ground slope. In the middle of the wall, 1.1m above present ground level, is a sash window, 0.80m high and 0.70m wide. A ditch about 1.0m wide and 1.0m deep runs the length of the wall. Now partially filled by vegetation, this is possibly the remnants of the foundation cut which was not backfilled to serve as a drainage ditch taking water from the roof. There is no evidence of gutters or down pipes. The roof is of corrugated iron, now rusty with little evidence of its red paint. There are two rows of sheets of varying widths. Several sheets are now missing and were found lying on the ground nearby. The gaps expose layers of bracken and straw which seem likely to be the remnants of the original roofing material rather than an early form of roof insulation. A variety of hooks, eyes and brackets project from the top of the wall to hold securing ropes.

the door. The two rows of corrugated iron are more regularly sized than those on the east roof. Again several sheets are missing. Two skylights are located in the roof above the windows but we were unable to measure these for Health and Safety reasons. The glazing and frame of the north skylight is missing and that to the south is boarded over with corrugated iron. On both sides of the roof the corrugated iron is covered with a cement lining at the gables.

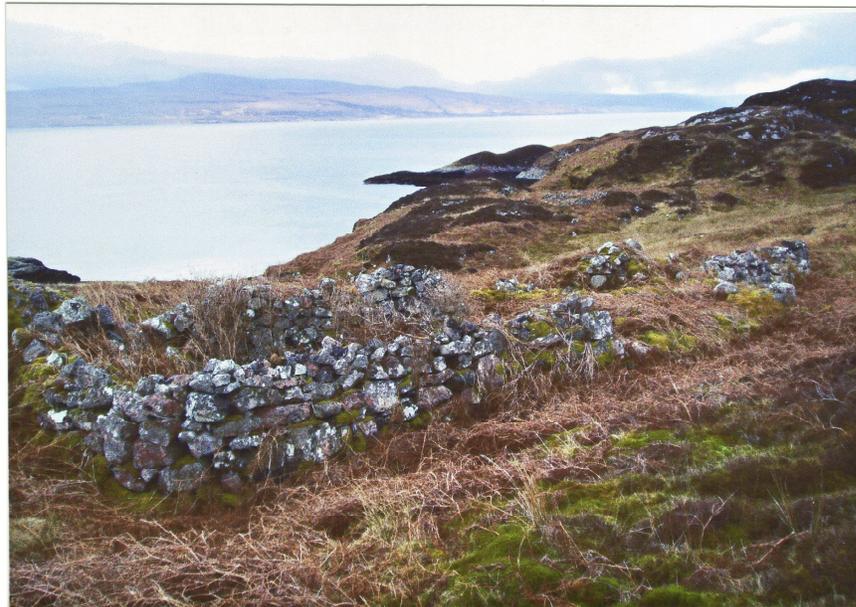
Plate 1 Multi Period house, Kyle Rona [KR Feature 3]

This is a somewhat complex structure which may cover multi-purpose and multi-period use. While compartments A to C appear to form the original round cornered house 8.50m long by 3.40m wide, with a 3.0m annex, there is evidence of earlier foundations under its basal courses. With square corners compartments D and E could be taken to be a later construction. However they underlie the earlier foundations on which A to C sit! There is no evidence remaining of windows or any internal features in any of the structures. At best therefore it is suggested that D / E was the original small house later used as a byre and A / B / C form the latest house and annex built on the foundations of an intermediate building.

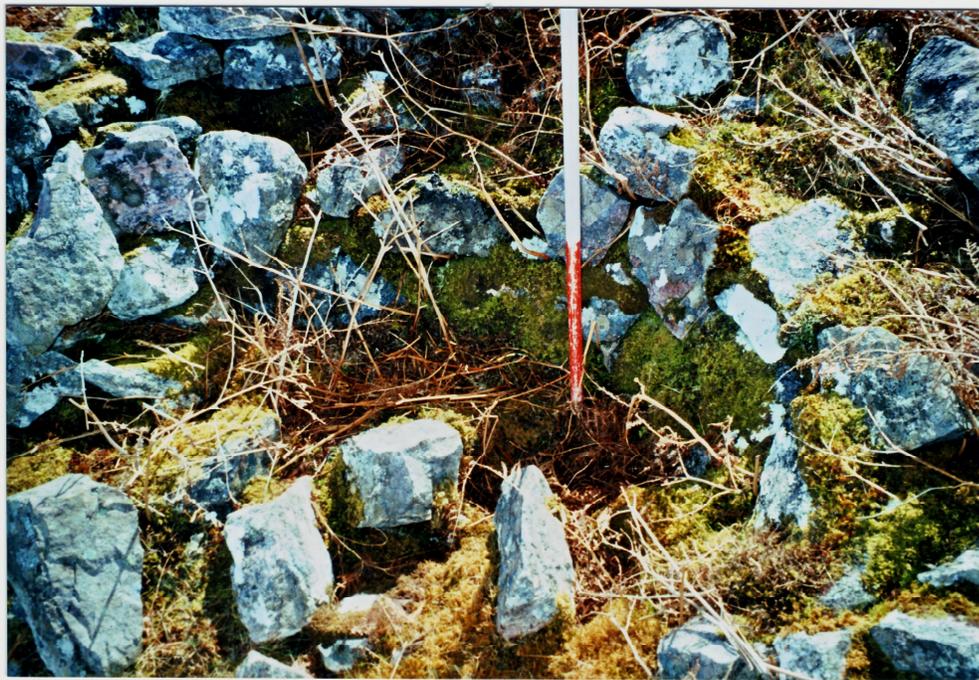
Plate 2 Kiln Barn, Kyle Rona [KR Feature 4]

Feature 4 Kiln Barn NG 6094 5304 [25m OD]

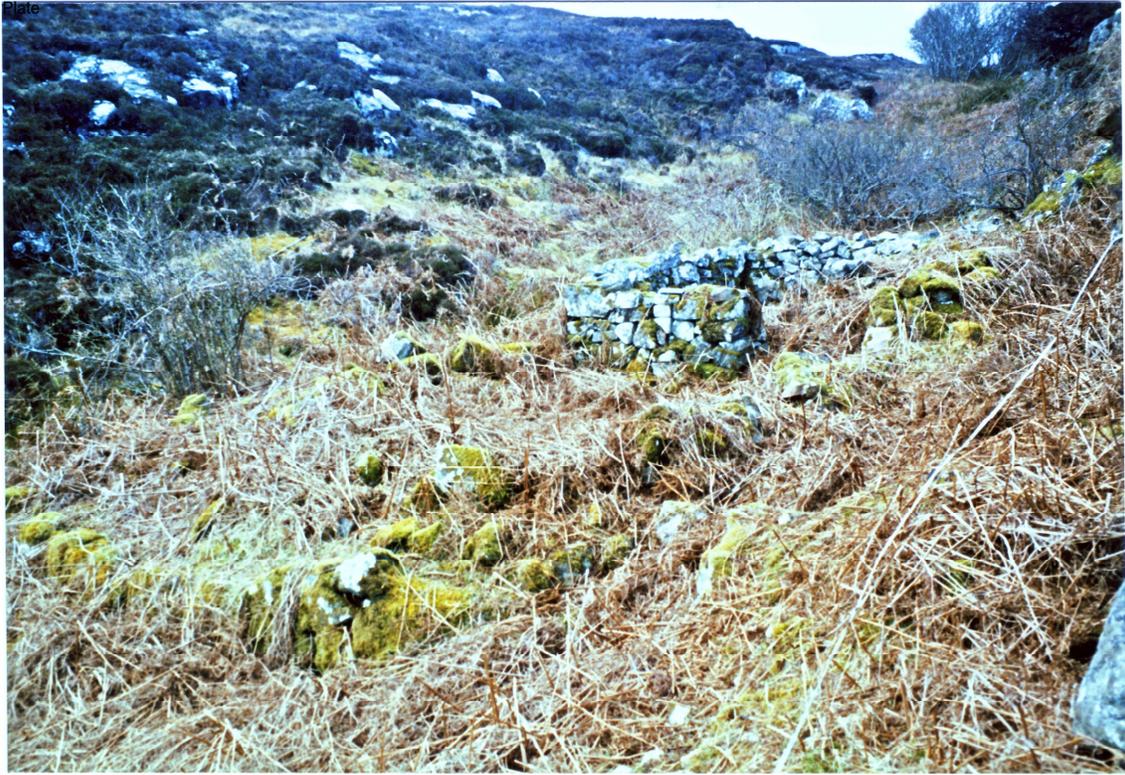
Plate 3 Multi-period Structure, Kyle Rona [KR Feature 15]

In the gully on the north bank of a burn hidden by vegetation, as is the fence line, is a multi phase structure, the final phase of which is clearly upstanding. The whole structure may be about 9.0m long on an east-west axis, assuming it does extend under the full footprint of the final phase. The remains of only the east end of a building (phase 1) about 4.0m wide, with rounded corners, can be seen protruding from under the phase 2 structure. [see Plate 3]

Phase 2, at least 1.0m shorter, has a rounded east gable and is about 3.60m wide with walls standing to a maximum height of 0.50m and 0.70m thick. There are two possible entrances midway in the north and south walls but these may be disturbances caused by construction of the final phase or later tumble.

The original building, and even phase 2, may have been a house, but the final structure looks more like a store.

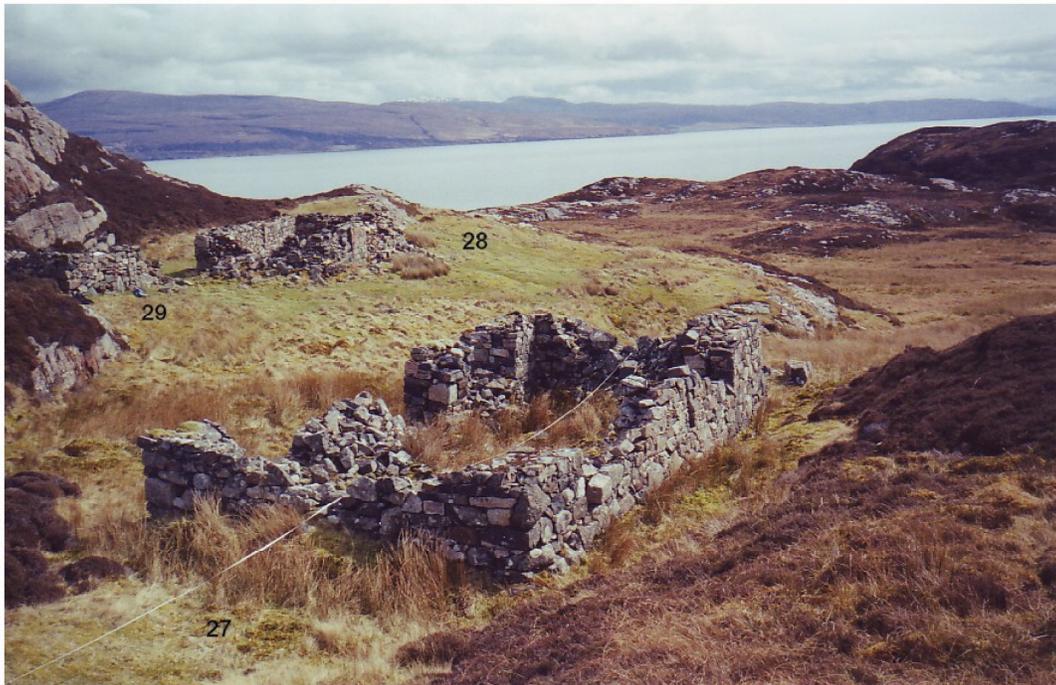
Plate 4 Large House, Kyle Rona [KR Feature 27 with 28 & 29 in background]

Surprisingly there is no evidence remaining of internal features. Neither a fireplace nor dividing walls can be seen and both these must have existed in such a finely built house if that is what it had been. In places between the stones there is evidence of mortar having been used but it is not clear whether this was used in the original build or for repairs. Close to the middle window on the back wall and inside the west corner small patches of lime plaster still adheres to the stone. The lime content had clearly been obtained by crushing shells which are still evident in the plaster. Such decoration of the walls serves to underline what a fine house this had once been.

One piece of artifactual evidence was found lying in the building. This appears to be a fragment of a grille from a corn drying kiln. Probably of iron, the triangular fragment measures 130mm by 145mm by 180mm and is about 4mm thick. It has rows of tapered, oval shaped, holes 13mm by 20mm, 30mm between centres and 15mm between rows. However there is no evidence of a kiln in this part of the settlement, the nearest being at Feature 4, nearly 1km to the north.

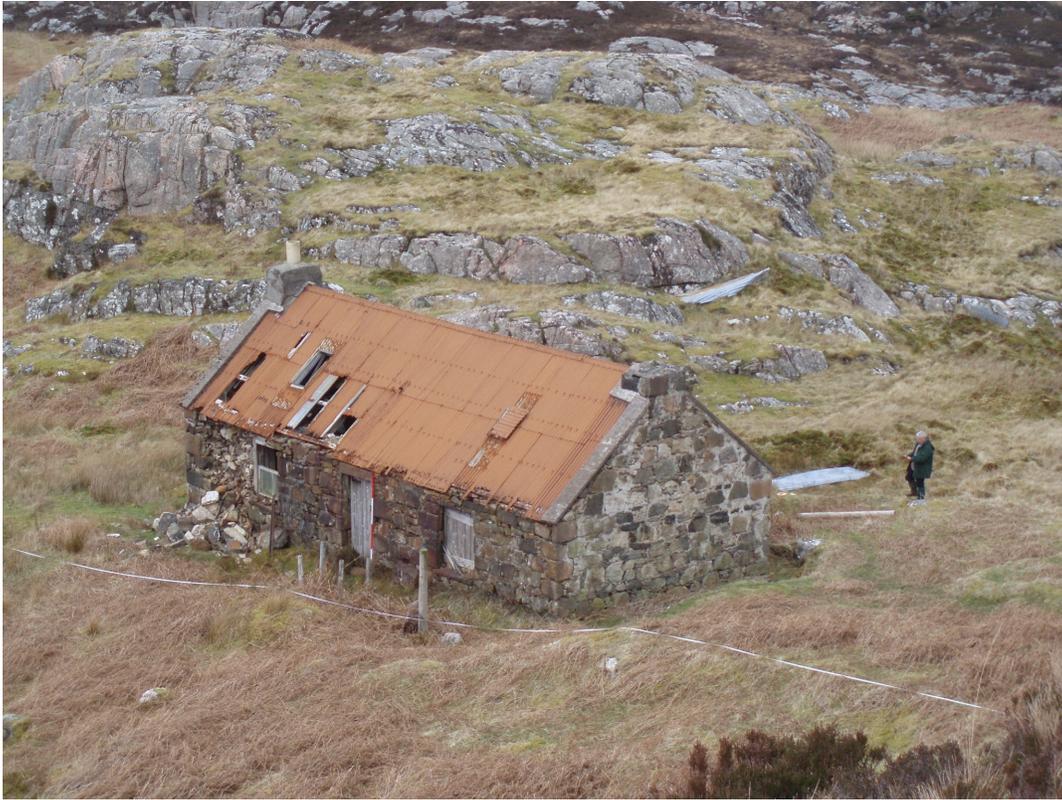
Plate 5 Tigh an Achaidh [Achadh Feature 5]

This house which is very evident from the track, is *Tigh an Achaidh* itself, also sometimes referred to as “Kyle Rona House”. However its landmark red rusted corrugated iron roof is rapidly deteriorating and decay is now causing the start of wall collapse. The survey of this building gave us a unique opportunity to examine a typical 19th Century Raasay croft house in its near original state. [see Plates 5 & 6]

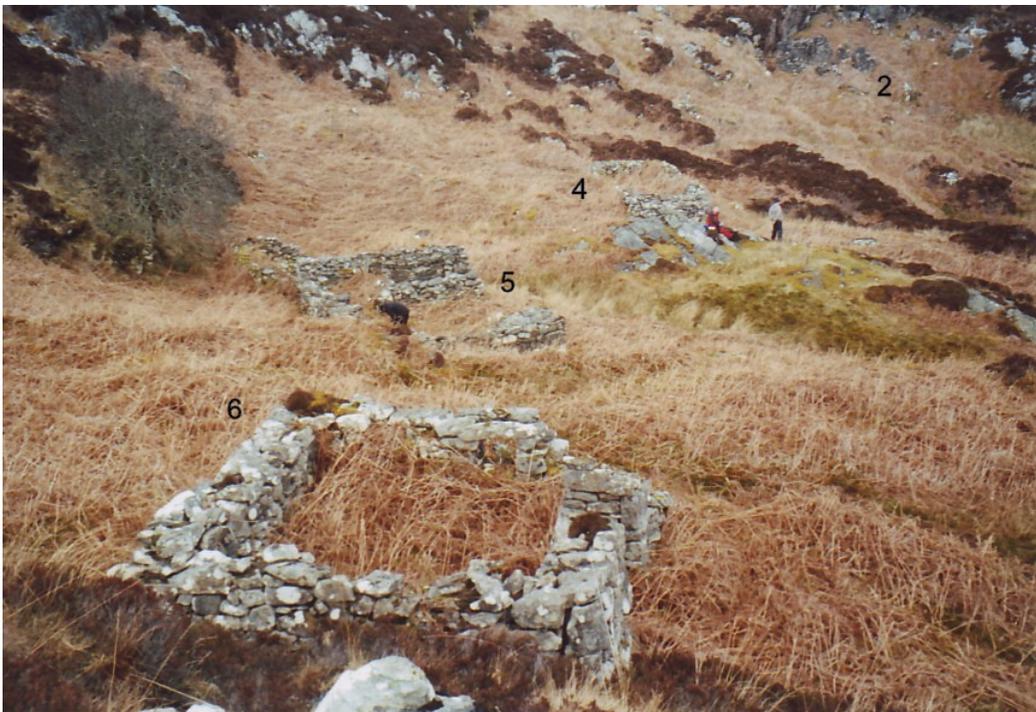
Plate 8 View of Doire Dubh from south

Doire Dubh lies near Lochan gun Grunnd nearly 5 kilometres north of the end of the tarmac road at Arnish. Hidden over the ridge to the east of the track, the small settlement of no more than six structures [see Plate 8] is in a defile running northeast to the inlet on the west side of Rubha Ard Ghlaisen. A black and white mast stands on the top of this headland. This is probably a sighting point for the Royal Navy submarine exercise area in the Inner Sound. The remains of older masts can be found lying on the headland.
