An Archaeological Survey
of the township of Manish Beg,
with a survey of the surrounding area,

Raasay

Portree Parish
Skye and Lochalsh District
Highland

Association of Certificated Field Archaeologists
(Glasgow University)
Occasional Paper No. 43
1999

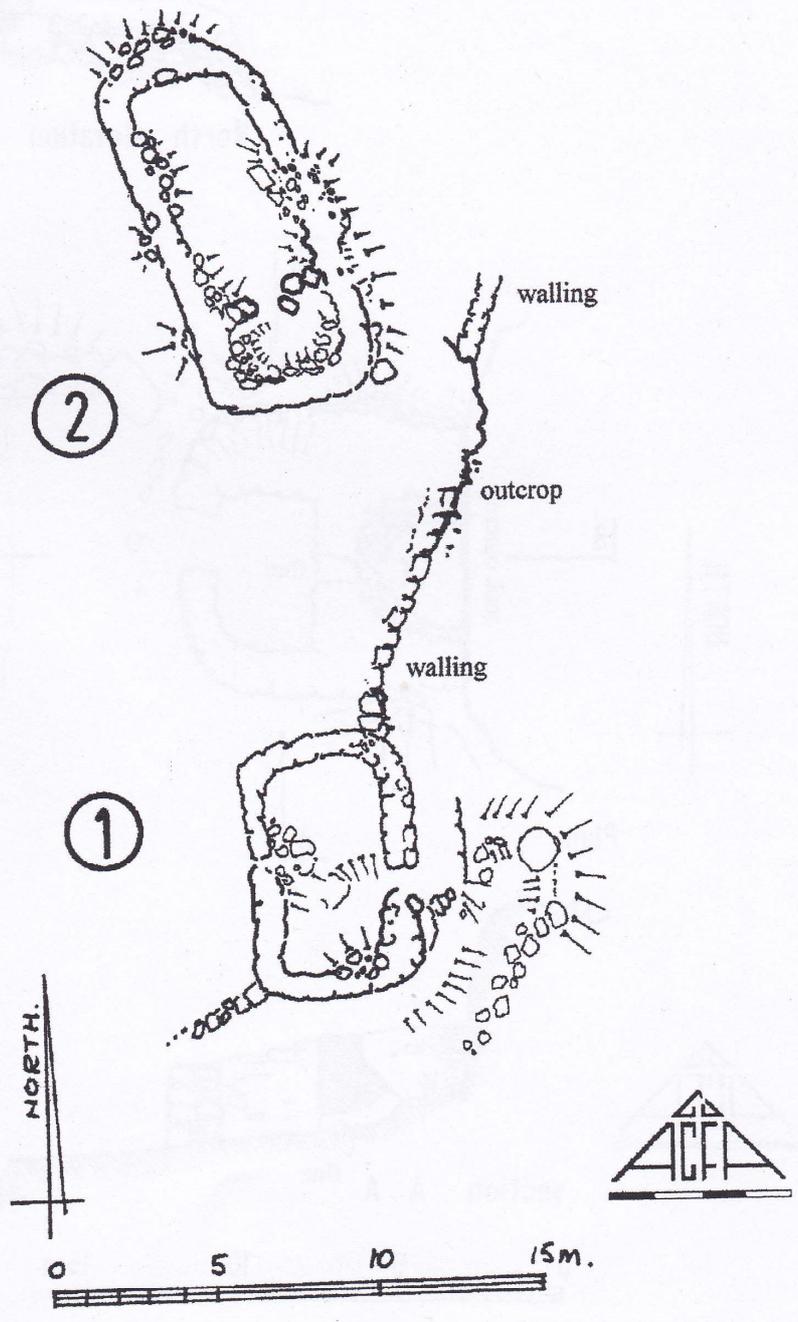
Manish Beg Corndrying kiln.

This well built and well-preserved kiln is standing to around its original height. It lies east-west, with the back of its bowl built against a broad slab of outcrop 2m high. The structure consists of two elements. The first is the bowl, which is complete and is D-shaped. Its stonework is vertical in the three or four upper courses, then battered inwards. There is rubble in the bowl, but the flue is visible. The north wall of the bowl is of a significantly heavier build than the south side. To the east of the bowl, and built on to it, is the second element of the structure. This is a D-shaped compartment the west wall of which is butt jointed to the side walls on the interior. It has the flue hole in its bottom centre, at ground level. The flue is 0.4m square. The rather small lintel of the flue is cracked in the middle but is not discoloured by fire. The entrance to this compartment is on the east and is 0.8m wide. The south edge of

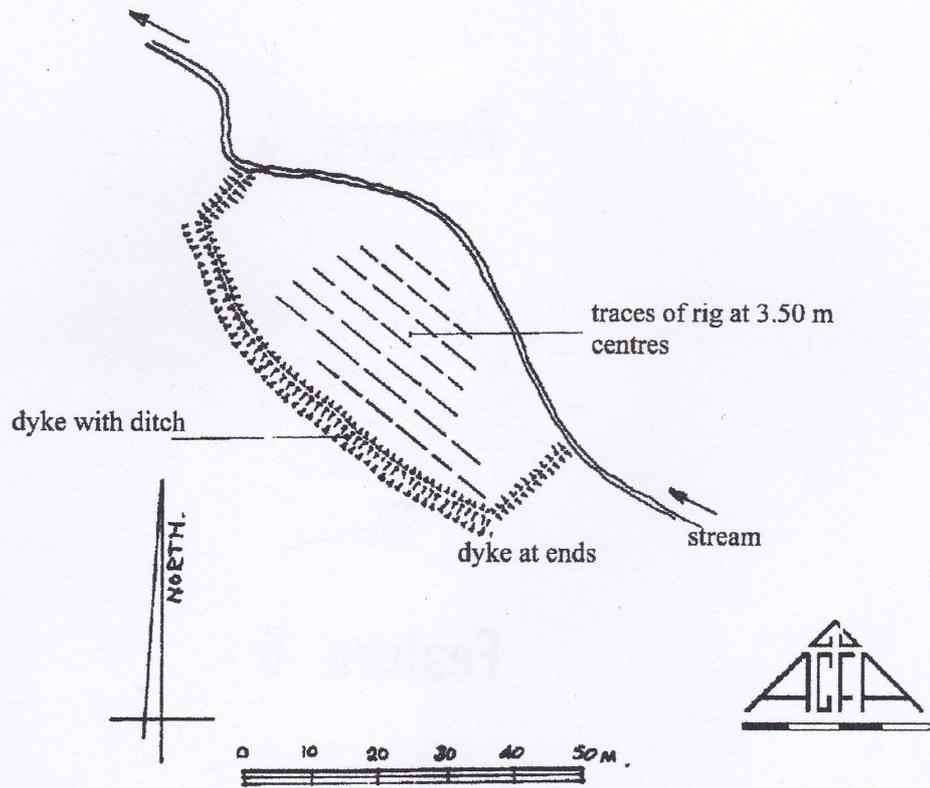
Feature 7

Lying in a hollow between two rocky ridges on the west bank of a burn, a well drained enclosure (63m x 33m) is defined by substantial turf and stone banks or dykes. The east dyke alongside the burn has served to revet the bank and thus deepen the burn. There is evidence of a ditch cut outside the west dyke. While the area outside the enclosure is covered in deep heather, the interior vegetation is largely moss and bracken. There is some slight evidence of rig and furrow in the centre and, at the north end, a stony spread with a stray length of banking may be the result of clearance. The enclosing dyke is at its highest, 0.9m to the south (0.4m elsewhere) with a spread of 1.5m at its base. It is well built with substantial stone outer facings and turf fill.

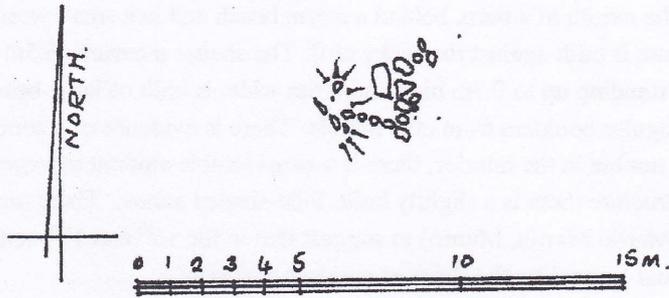
Feature 8

About 200m north of the road as it turns towards the east is a heather covered, sub-rectangular turf and stone structure [A] sited on a platform, 1m higher than the surrounding area. With the long axis northwest-southeast the building measures 4m by 2m internally. Walls are standing to a height of up to 0.6m and are 0.8m wide. There is evidence of a doorway in the northeast wall. About 8m away a curving turf and stone bank defines the north and west sides of the raised heather covered area on which the building is sited. The bank remains up to 0.5m high with a spread of 1m. The east of the area is bounded by a burn. Built into the bank and clearly post-

dating it is an ovoid, turf and stone structure built on a low mound. The walls stand to 0.3m high and enclose an area up to 2m in diameter. Close by to the south a low stone wall, standing up to 2 courses (0.4m), is built into the bank. With the ovoid structure it forms a sub-rectangular enclosure about 2m by 1.5m with a possible doorway in the northeast corner.

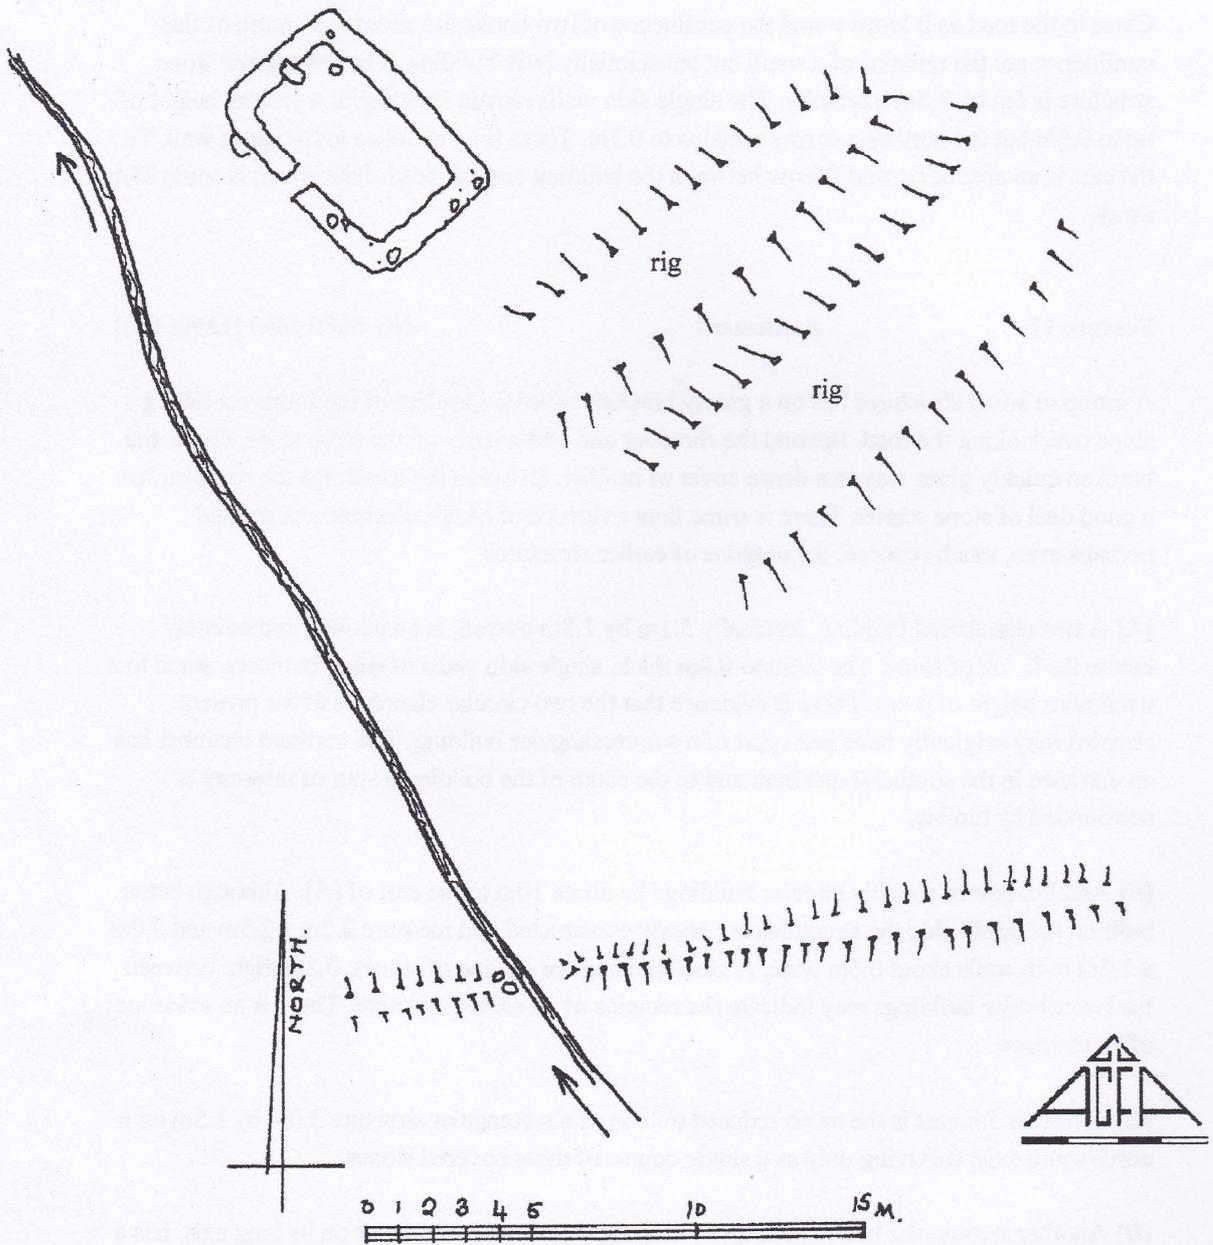
Feature 10

[D] Another rectangular building, 2.8m by 1.6m and northwest-southeast on its long axis, lies a further 8m east. It has been built of larger stones than [C] and, as there is less vegetation, there

are more stones visible. The interior is relatively clear of stone but there is considerable tumble outside. The single skin walls are about 0.6m wide with a probable entrance in the southeast. There is some evidence that the upper courses of construction could have been turf.

[E] Within a mass of tumble, 6m to the northeast of [D], a well constructed length of wall built into the slope forms a small chamber about 1.2m square. The 0.6m wide walls stand to a height of 0.3m. Although the front of the structure is lost in the tumble the location gives the impression that this could be a small kiln.

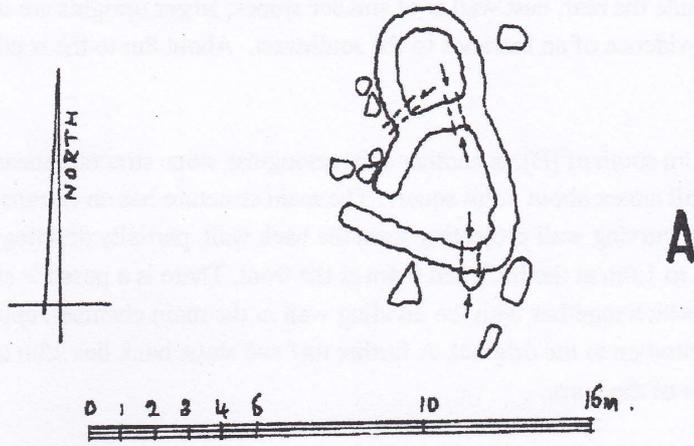
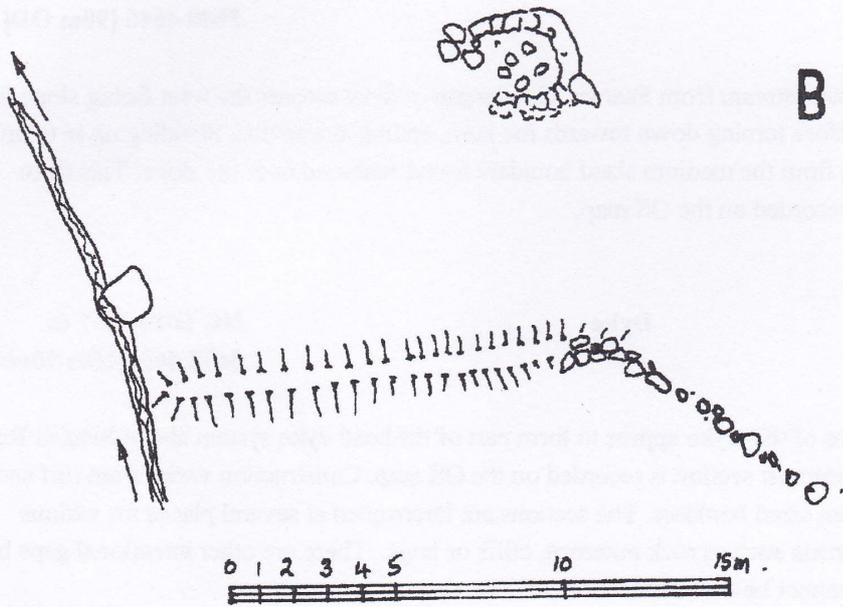
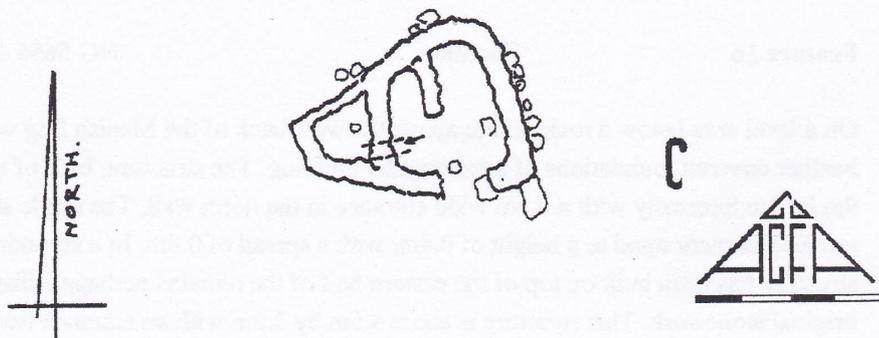
Feature 13 shieling settlement.

[A] Close to the burn to the west of the above, a sub-circular sheiling type structure, 2.5m by 1.5m has walls standing to a height of 1.2m. With large boulders incorporated in the base course, there is evidence of an underlying plinth or platform at the front / west side. A larger sub-circular annex abutting to the south is 3.5m by 3.0m standing to 0.5m high. There is an entrance, with a sill, to the sheiling in the south west corner where the two structures join. The annex appears to have a 0.8m wide entrance from the west and another door between the two structures internally, both with sills.

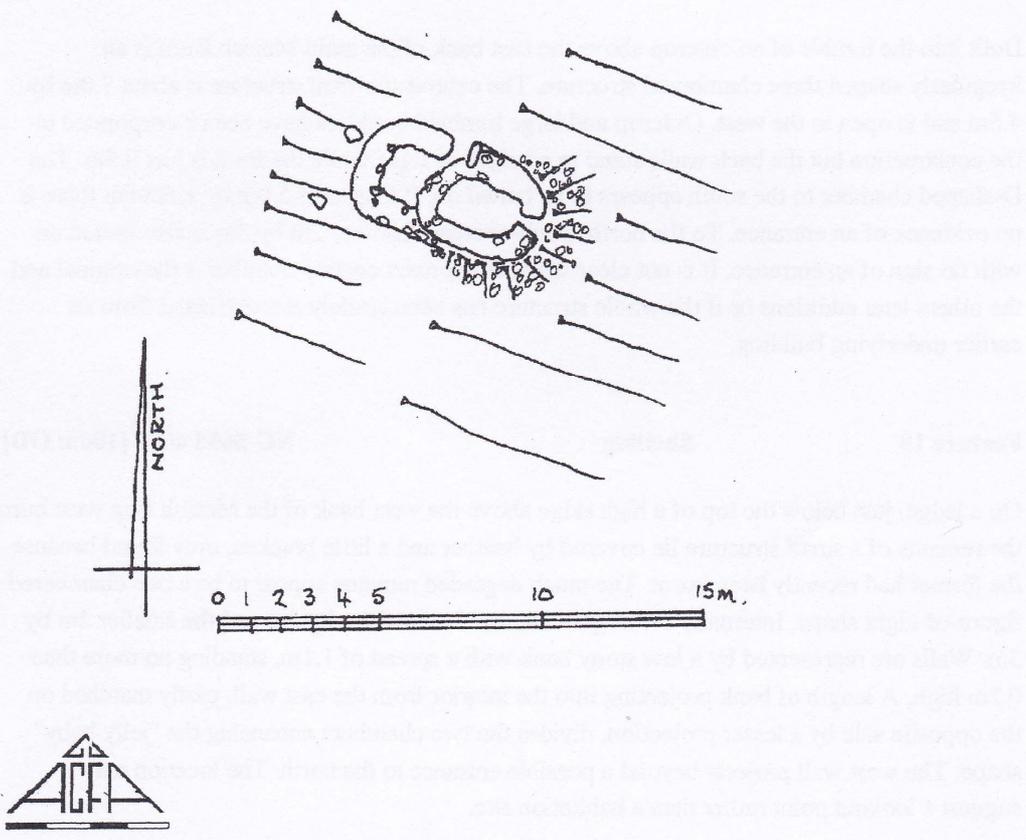
Feature 16 is a large, irregularly shaped structure, possibly a platform or a large pit, located in the center of the site. It is surrounded by a low wall or embankment. The structure is oriented roughly north-south. The interior of the structure is filled with a dense pattern of small circles, suggesting a floor or a specific material. The surrounding area is marked with several long, parallel lines, possibly representing a path or a boundary. The drawing is a plan view, showing the layout of the feature and its immediate surroundings.

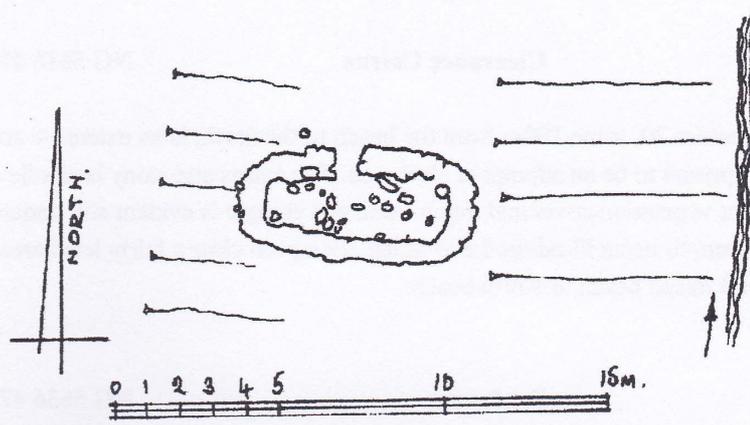
Feature 17

About 25m northeast of Feature 16 are the remains of a roughly rectangular building, 11m by 4m on an east-west axis. Beyond the door in the north wall, the western part of the building is narrower internally by about 1m. The substantial foundations clearly show a double-faced rubble infill construction with the east end wall rounded. While the west end is also rounded externally the corners inside are squared. This end also appears to be built on a platform, perhaps all indicating that some reconstruction has taken place. There are no other discernible features in the vicinity to give an indication of the use of the building.

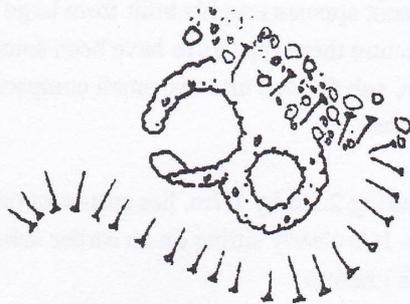
Feature 26 shieling .

A figure-of-eight hut lies snuggled under, and to the south of, a rocky outcrop in a natural narrow gully to the east of the burn about 200m from the beach. The structure is typically crudely built with irregular stones from the cliff tumble. The western chamber is approximately 2m in diameter while that to the east is about 1.5m. There appears to be an entrance at the west end.

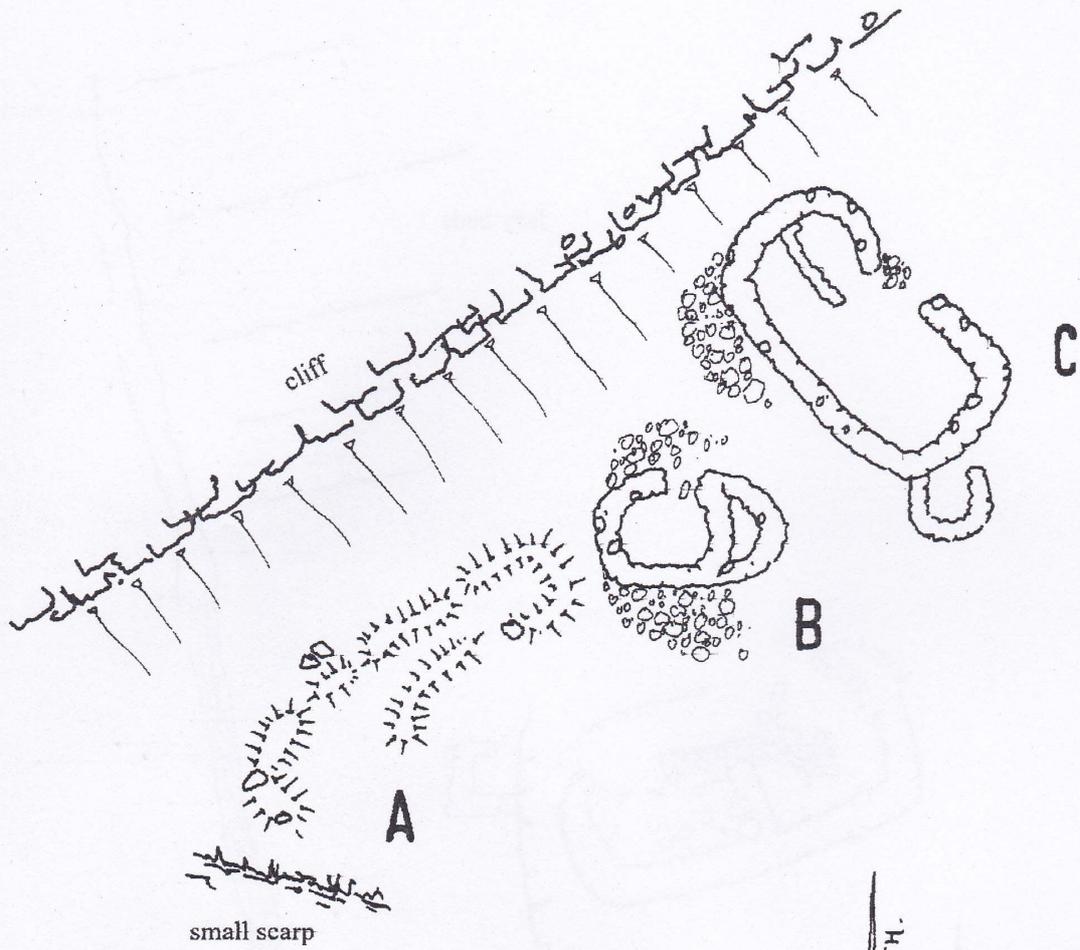
Feature 30

Above Loch na Bronn, on a shelf with an easterly outlook and a steep rocky slope down to the Loch some 20m below, is a small settlement with about a dozen structures apparently covering a long period of use. The main structures ([A] to [C]) are tucked under the rocky cliff which forms the west boundary of the site. The subsidiary structures at first appeared to be mounds of clearance but there appeared to be no reason for attempting clearance and little success. Closer examination revealed some to be small enigmatic structures of indeterminate purpose or date.

[A] A long bow shaped structure lies roughly north-south. The structure looks like a series of 'jelly baby' houses and is constructed of mainly turf, with some stone. It is difficult to identify separate chambers but the whole structure is nearly 10m long internally. The walls are much degraded and in places there is only very slight evidence of a turf bank to denote the position of the walls.

[D] An area of much degraded lazybed lies 10m to 15m to the north of the house [C].

About 10m to the south east near the scarp edge are the much destroyed remains of another possible structure.

[G] 10m south of [F] is another low oval bank with a spread of 0.6m, 0.2m high. This feature measures 7m by 4m with a possible entrance in the west.

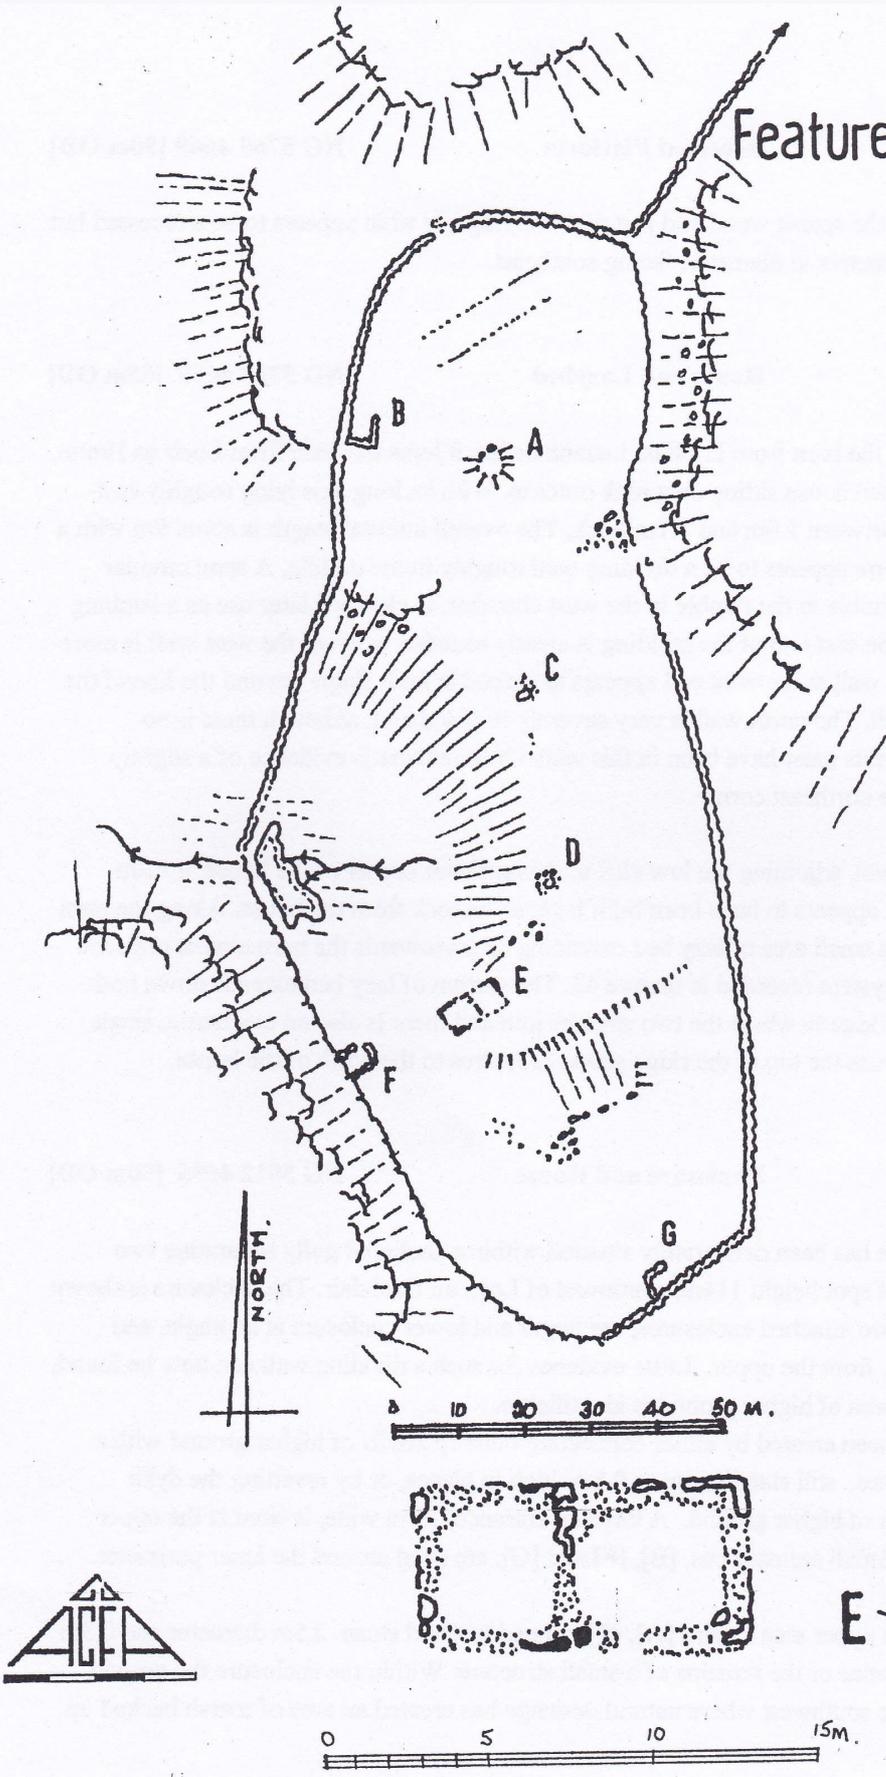
Feature 34

This large enclosure has been deliberately situated within a sheltered gully separating two knolls to the west of spot height 114m, southwest of Loch an Uachdair. The enclosure is shown on the OS map as two attached enclosures, the larger and lower enclosure at an angle, and separated by a wall, from the upper. Little evidence for such a dividing wall can now be found, although an upper area of higher ground is identifiable.

against the perimeter dyke. The rim of this fall of ground is marked by clearance cairns and stony scatters [C] and [D].

In the middle of the larger southern expansion of the enclosure is a small, double compartment house [E], 10.2m long east-west by 5.0m wide, with a possible entrance on its south side into the southeast compartment. No internal features are visible.

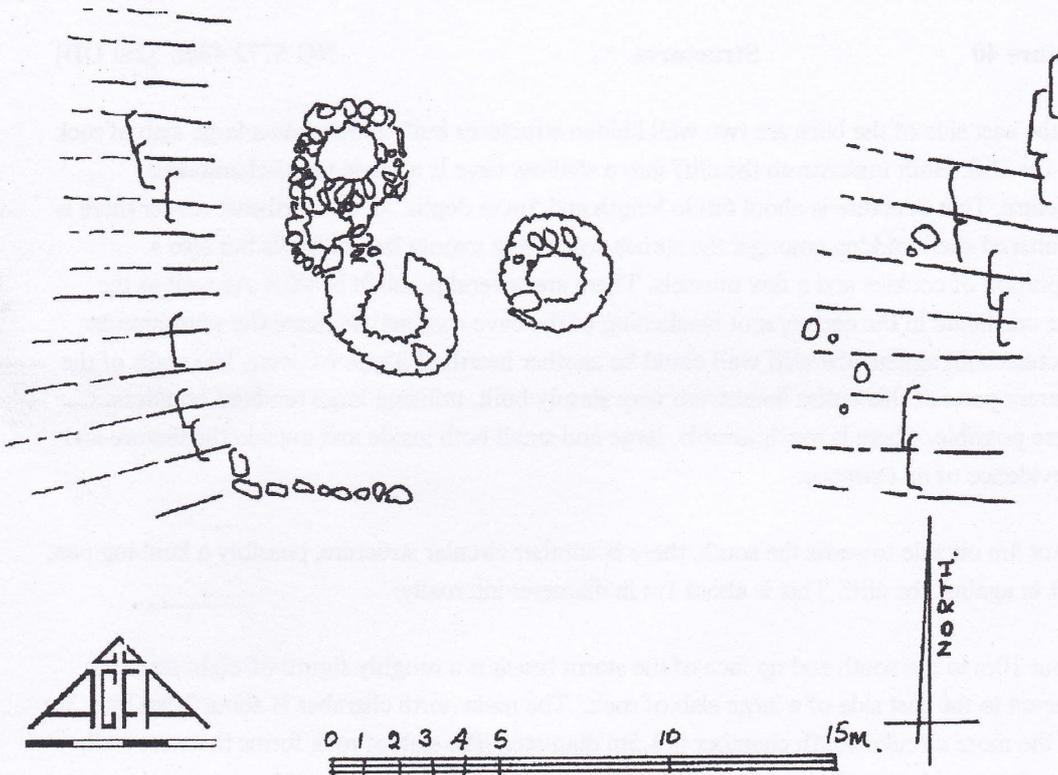
Feature 37 shielings

On a natural terrace 25m above the east bank of the burn, a cluster of four sheilings lies in the lee of a small scarp. The south edge of the terrace appears to have been defined by a low turf and stone bank. Beyond the cluster are at least two small clearance cairns to the northeast and southeast of the site.

There are several other indeterminate structures constructed from this scree slope.

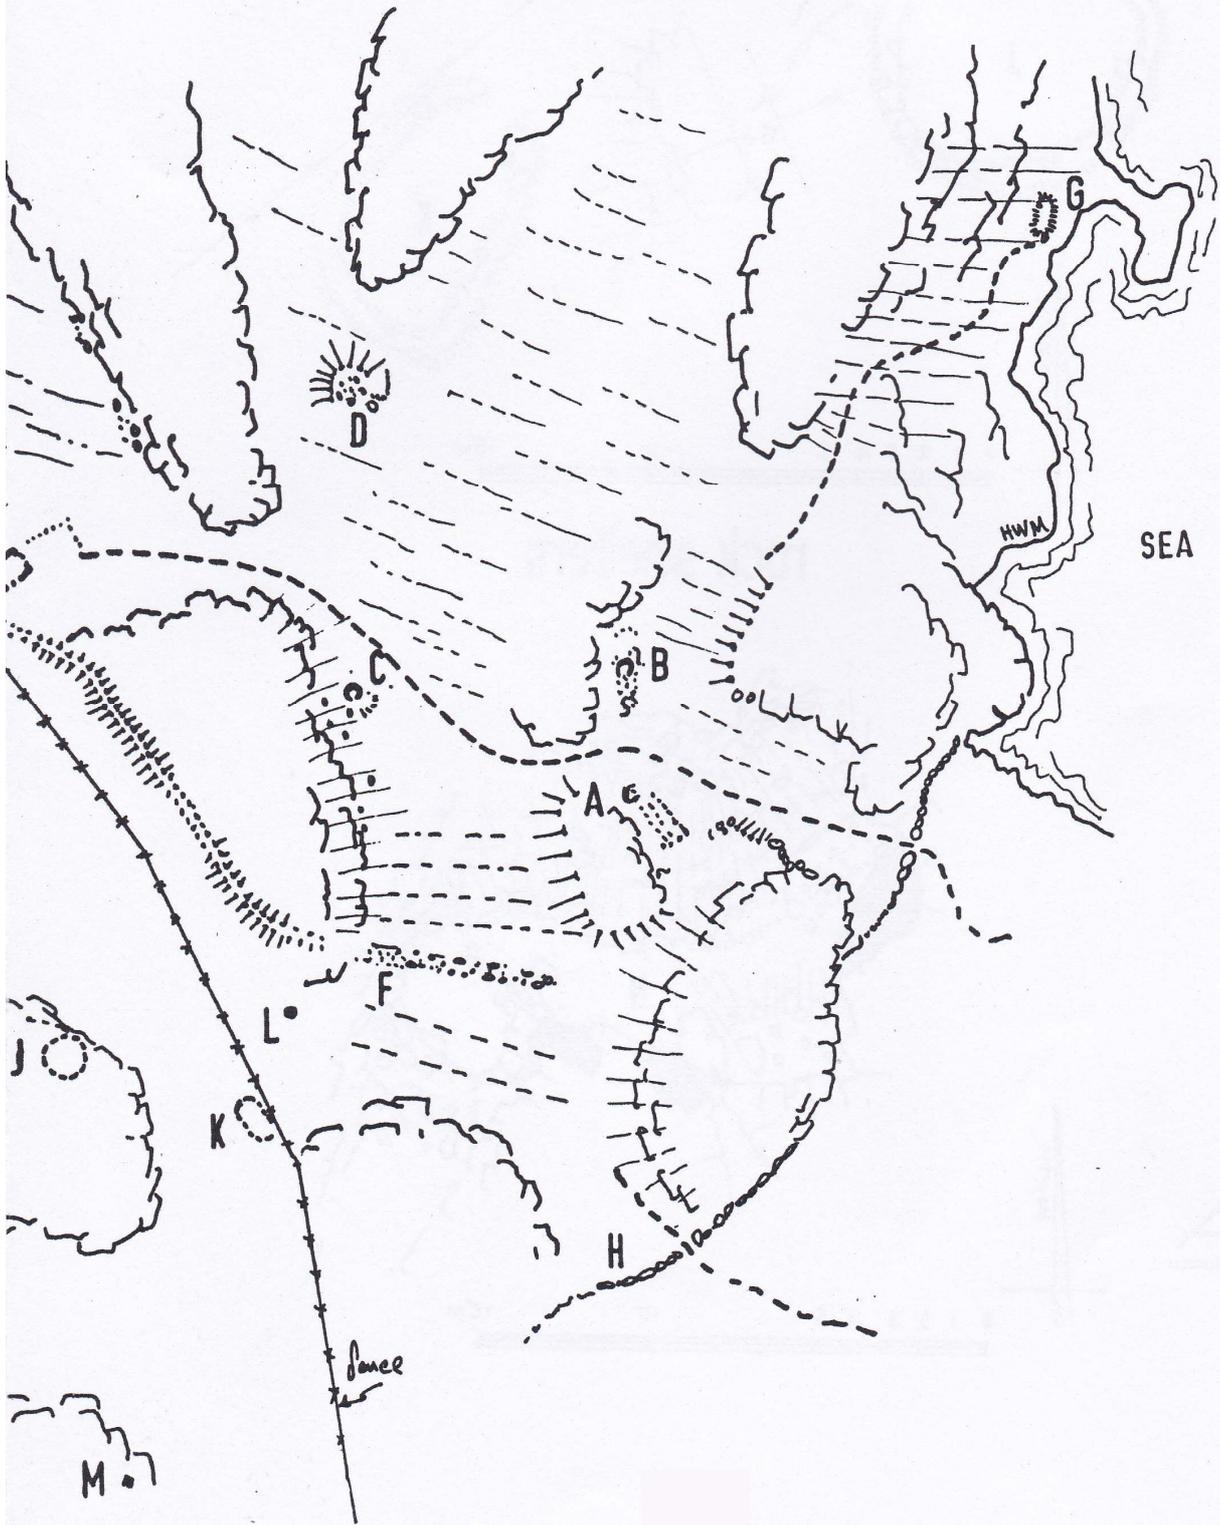
Feature 44

[C] Situated on the slope and from the scree of an eroding natural knoll is a small circular structure, 2.4m external diameter and 1m internal diameter. The walling is still standing up to 0.8m high with an entrance on its south side.

[D] A large, ovoid clearance cairn 6m to 8m long still stands 1.8m high in the centre. It appears to have been created on a natural knoll which tails off to the north. On its east side a sub-rectangular sheiling has been created from its material measuring 5m long north-south by about 3m wide, the south end and the east long wall being most evident.

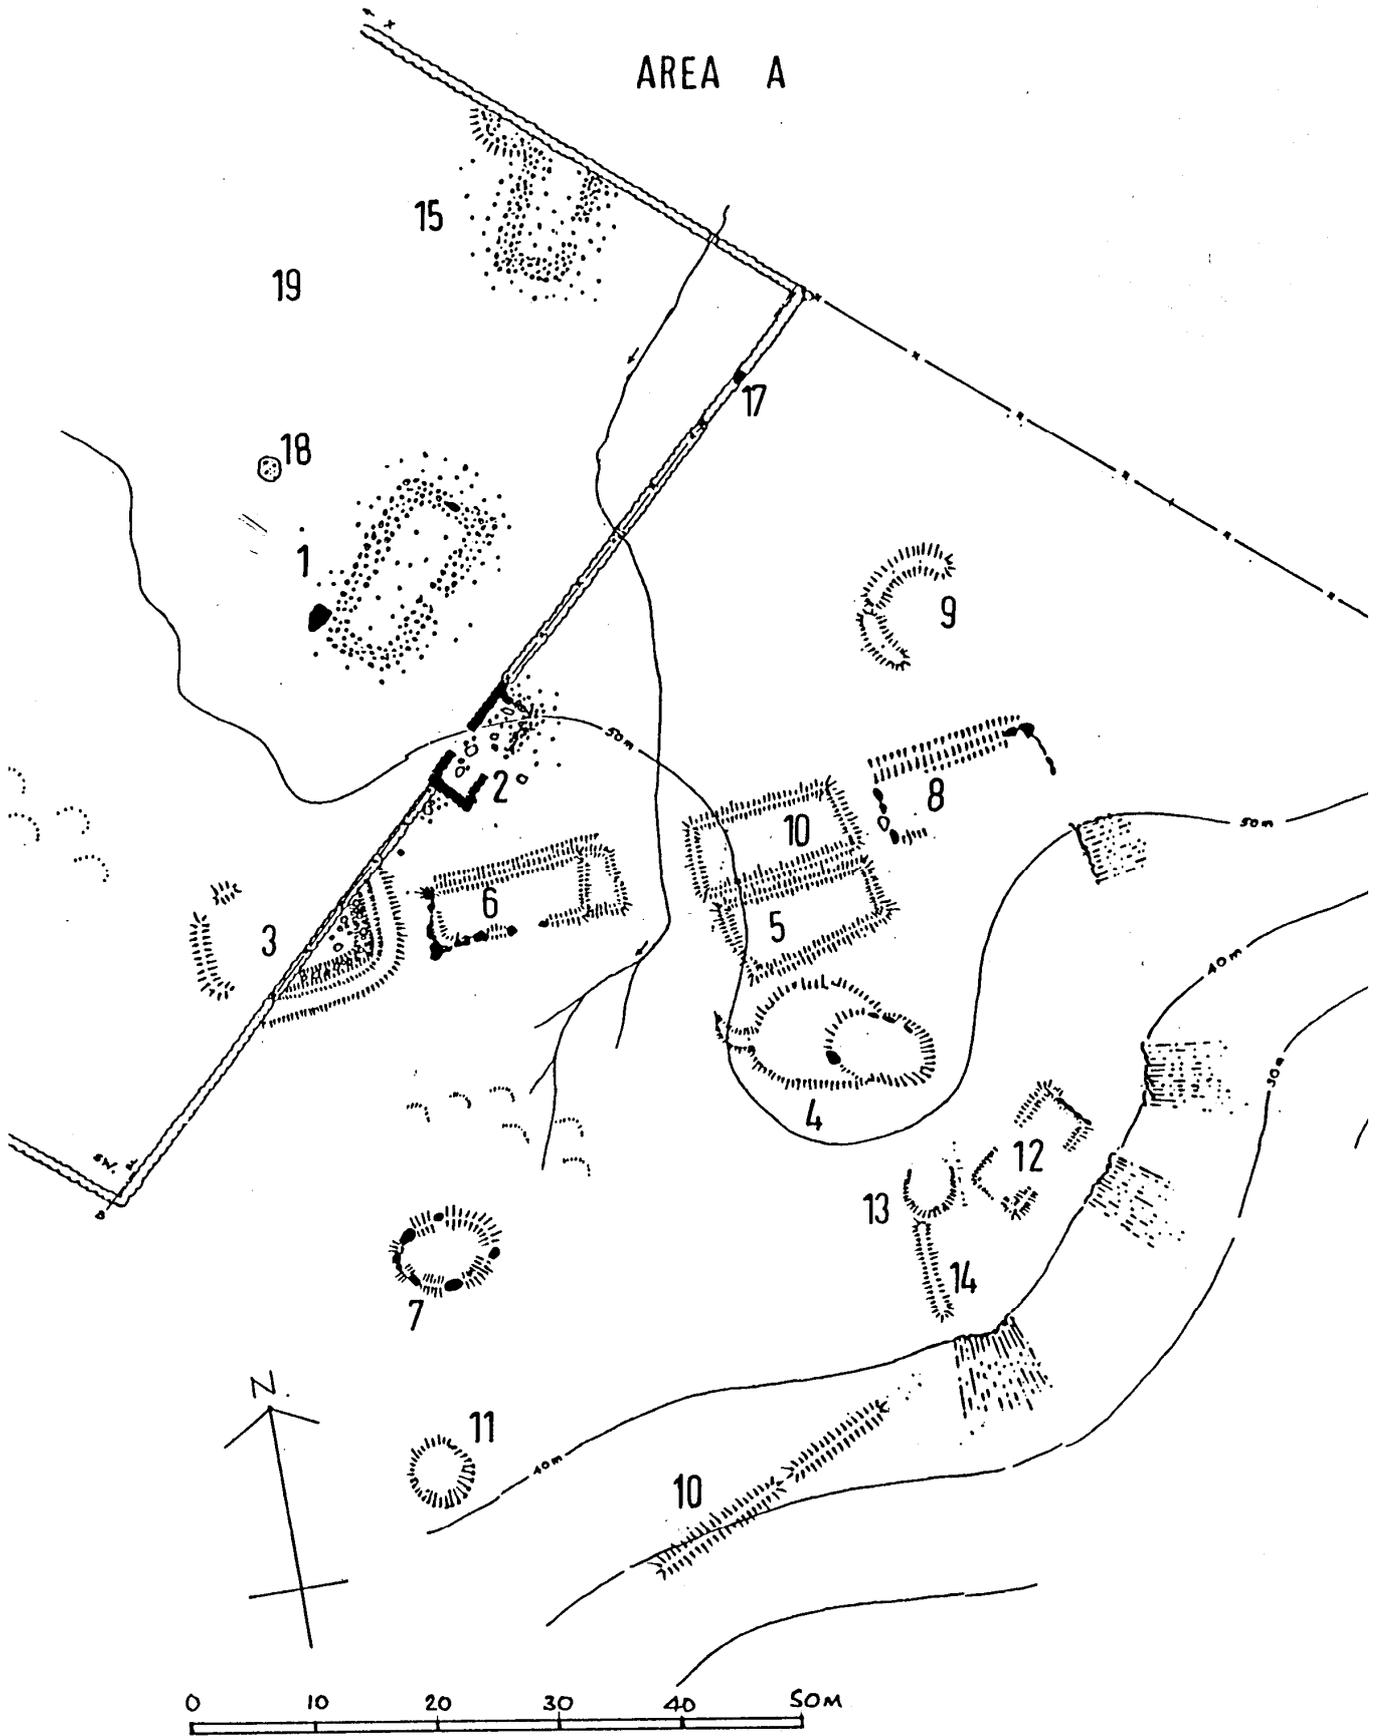
AREA A

Feature 4 **Oval Area** **NG 5777 3426**

This feature is an oval shaped area, 7m x 4m, cut into the side of sloping ground with a rear scarp rising to 1m in height and with a front apron dropping 0.3m onto a lower circular area of approximately 8m in diameter. This circular area then drops 0.3m to the natural ground surface.

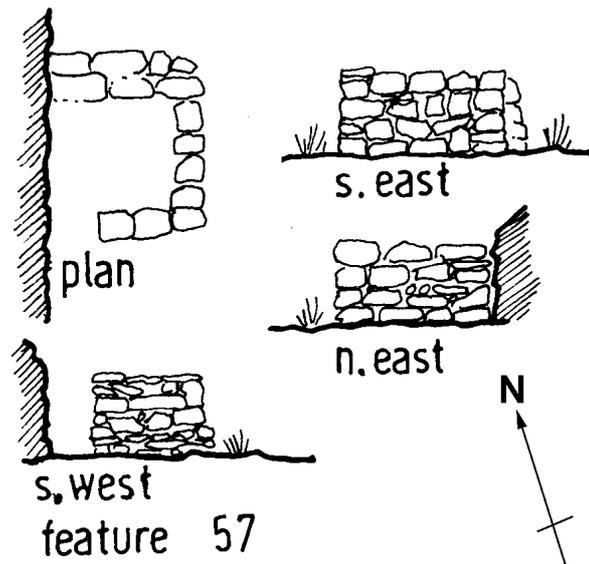
Feature 57.**Pen****NG 5728 3453**

A small stone built pen, measuring roughly 2m square, is of drystone construction with walls 1m high and 0.5m thick. There is an entrance 0.5m wide on the south wall. The structure is situated in deep woodland beside a burn. It is well hidden from the surrounding countryside and according to tradition is a spirit still.

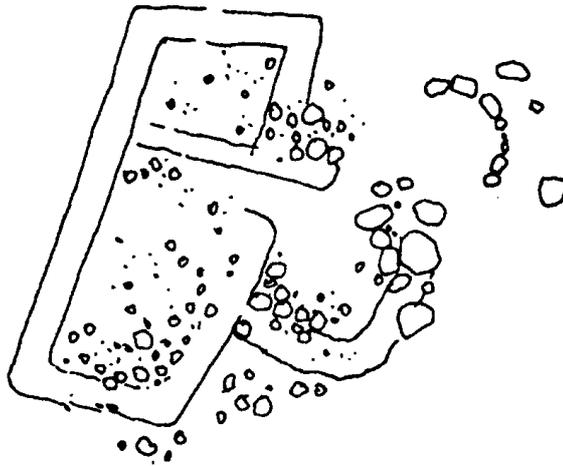
feature 14

Feature 14.**House****NG 5730 3467**

Situated on a south facing plateau 6m south-east of Feature 13 lie the remains of a ruined longhouse. It measures 9.8m x 3.3m internally and is constructed from rough boulders with walls 0.9m thick reaching a maximum height of 1m. Internally the north wall has square corners and is in a better condition than the rest of the structure. There is an internal dividing wall 0.6m thick which is situated 2.6m from the north wall.
