An Archaeological Survey
of the townships of Hallaig and An Leac
and the surrounding area.

Raasay

Association of Certificated Field Archaeologists
(Glasgow University)
Occasional Paper No 71
2004

RAASAY 2004

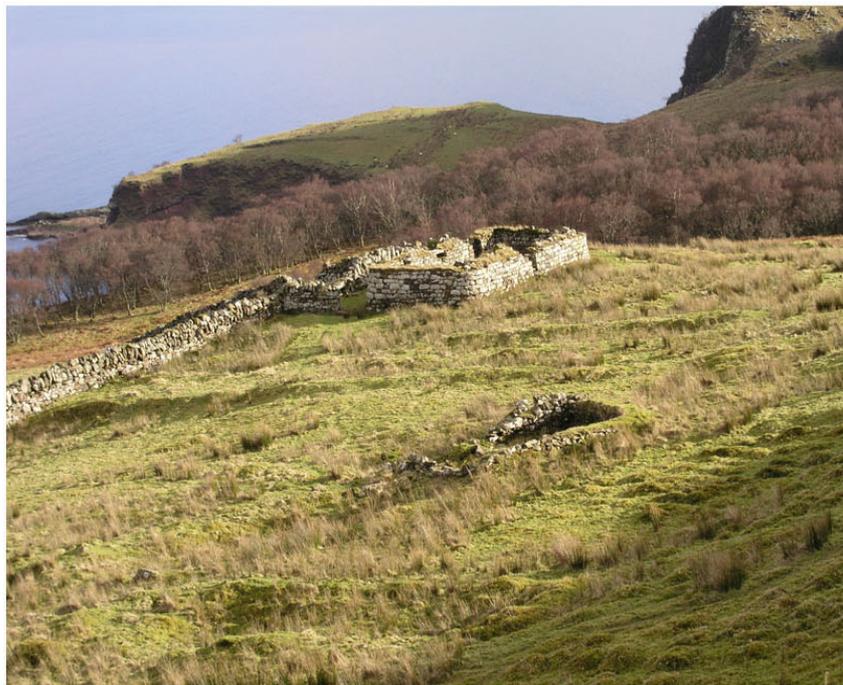
**View of Hallaig lower
showing the sheep fank and Feature 41**

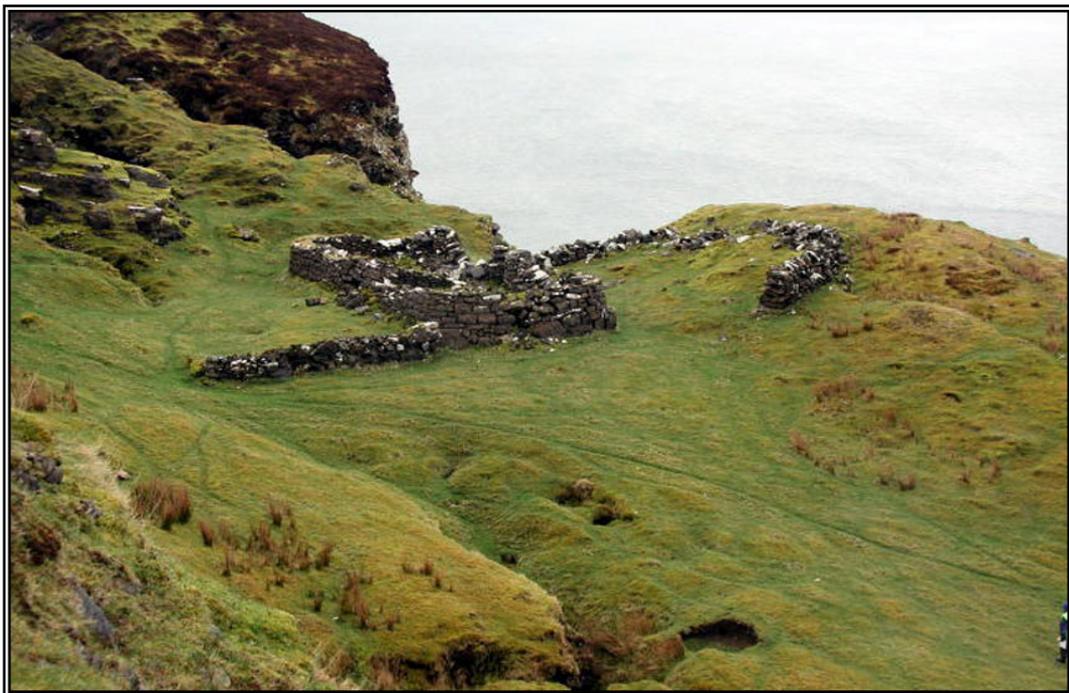
**Feature 7**

Approximately 80m to the north of the main settlement is an area of fairly steeply rising grass land with several deep fissures. An area of ground is bounded on the west and north sides by rocky scarps some 6m high and on the east side drops away very sharply. Lying within this area a substantial structure set north-south on its long axis measures 12.80m x 4.0m internally. The walls are drystone with some mortar visible. They are on average 0.80m thick and stand to a maximum height of 1.75m. An entrance 1m wide lies in the centre of the east wall. A cross wall 3m long and about 0.60m thick, divides the structure into two compartments, the north being 5.0m long and the south 7.10m long. The cross wall stops 1m from the east wall of the structure to form an entrance between the compartments. A fireplace about 0.70m across lies in the north wall and some breaks in the south wall of the structure may indicate another fireplace. There were no other visible internal features and no evidence of windows in the east wall which is quite tumbled. A stretch of rough drystone walling, 6.80m long, runs westwards from the southwest corner. Attached to the east wall, some 5m from the northeast corner, rough drystone walling forms an enclosure 10.50m x 5.50m which is open at the southwest corner. About 10m from the east wall of the enclosure the ground drops away very steeply and steep rock scarp lies approximately 12m from the west wall of the house. 1.50m from the north wall of the house lie the foundations of a small structure. As best as can be determined the structure has measured 5.60m x 3m internally. The foundations are clearly defined along the south and east sides but the west end is indeterminate and full of tumble. Rock scarp lies not more than 15m from the north wall of the structure.

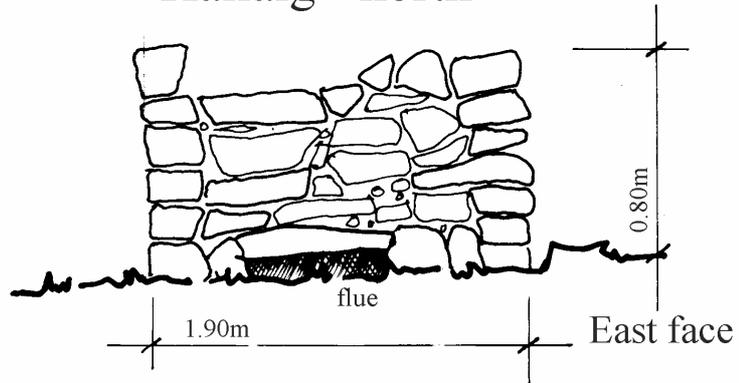
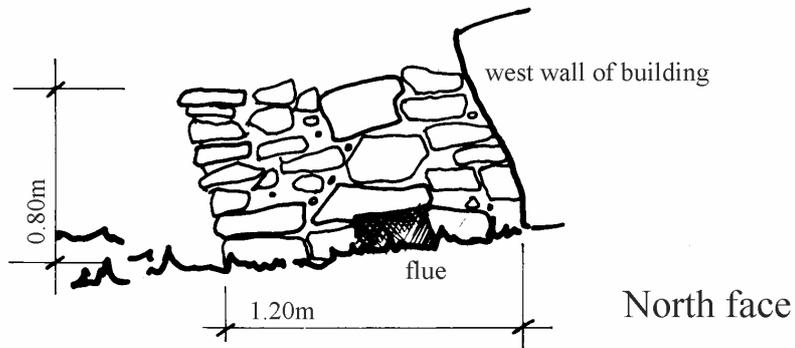
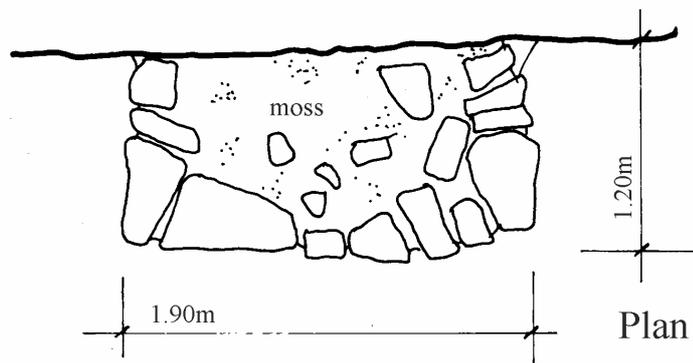
Detail of kiln at Feature 1

Lying behind a knoll are the upstanding remains of a long house set northwest-southeast on its long axis. The house measures 12.50m x 4m internally with drystone walls 0.80m thick and standing to a height of 1.70m at the north end and 1.50m at the south end. The corners are rounded both externally and internally and the walls incorporate some outcrop. The house has 2 compartments divided by a drop in ground level, the south section being 0.60m higher than the north section. The north compartment is 7m long and the south compartment 5.50m long. An entrance 1.10m wide lies midway in the east wall giving access into the north section and a window, 0.50m wide externally and 0.60m wide internally, lies in the east wall of the south compartment. In the west wall of the south compartment is a small aumbry, approximately 0.40m square. Situated in the northern compartment are two pairs of cruck slots with a possible third pair. In the southern compartment there is a pair of cruck slots in the long walls and in the south gable are a further two cruck slots. In the south compartment, built against the west wall, is a sub-rectangular stone structure, 1.90m x 1.20m x 0.80m high. At ground level in the east face and the north face are 2 vents, both more than 0.50m across, which extend as channels right into the hollow interior of this small structure like a flue. This feature is interpreted as being a small corn-drying kiln for domestic use. Boswell, in his description of his visit to Raasay, notes the presence of a corn-drying kiln inside a house in Screapadal, and this may have been a common feature of the houses.

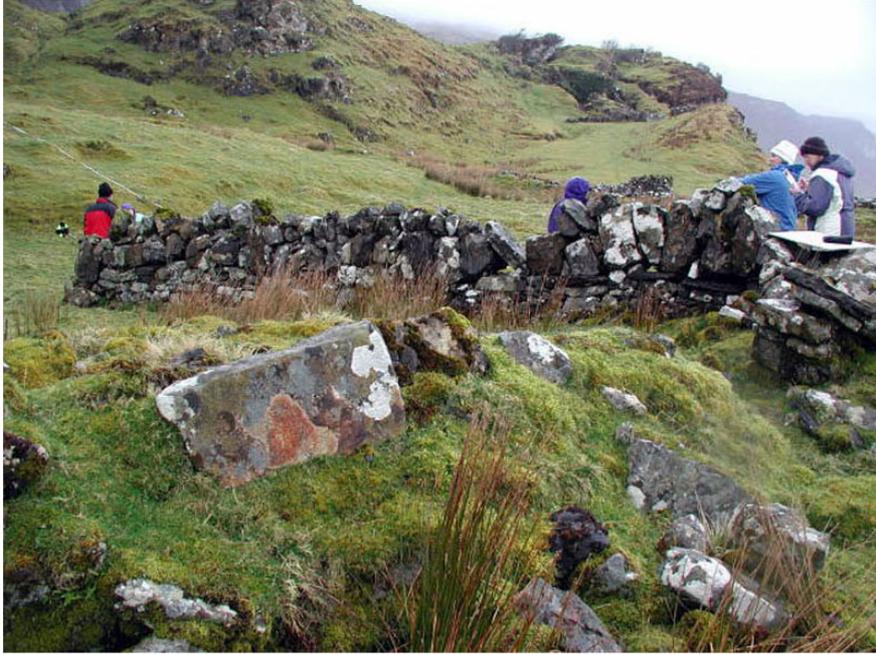
Feature 29

A sub-rectangular house lies northeast-southwest on its long axis and measures 11.40m x 3.65m at the northeast end and 2.90m at the southwest end. The walls are of drystone construction with no mortar visible, 1.40m high at maximum and 0.80m thick, but the south half of the west wall is low with tumbled stone under grass cover. The corners externally are all rounded; internally all are rounded except the northwest corner which is square. There may have been an internal cross partition which formed two compartments which measured 4.40m at the northeast end and 6.80m at the southwest end. There have been two opposing entrances 0.75m wide in the north end of the east and west walls but the east entrance has been carefully blocked up. A window 0.50m wide lies in the north end of the east wall. A cruck slot is visible at the north end of the west wall. There were no other visible internal features. From the northwest end of the building a roughly built wall extends for 10m. Outside the northeast end is a considerable pile of tumbled stone.

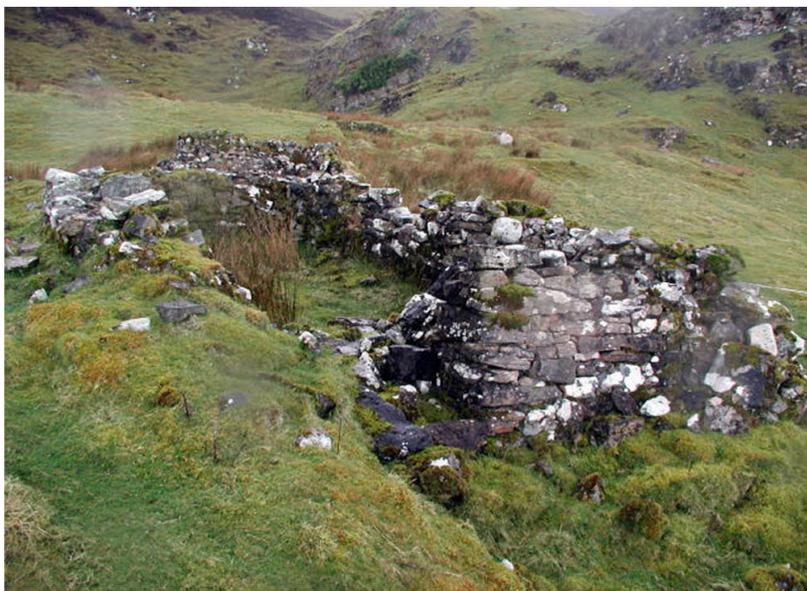
Feature 14

Lying 7m to the south of Feature 13 a drystone structure, 7.60m x 3.20m, lies east-west on its long axis. There is an entrance, 0.80m wide, in the north wall. The walls are double skinned with rubble infill, are 0.80m thick and stand to a maximum height of 1.70m. There are no internal features visible in the grass and moss covered interior but stone tumble lies in the northeast corner, at the entrance and outside the south wall.

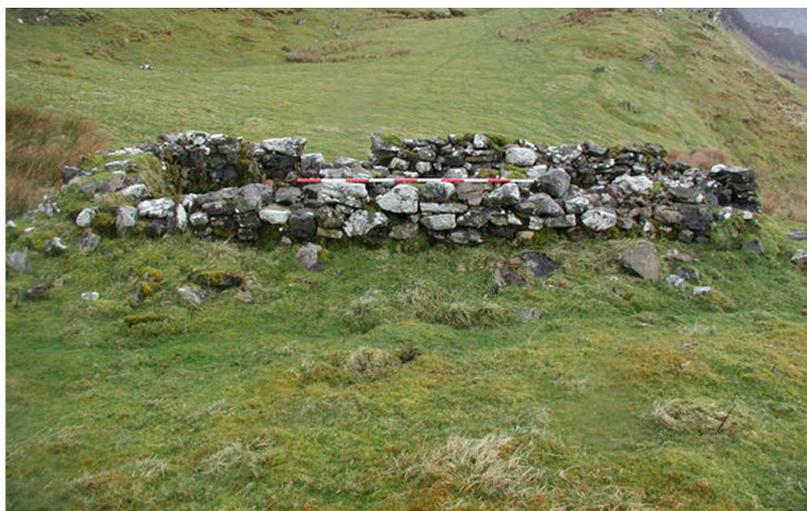
Feature 15

Lying 6m to the east of Feature 14 a ruinous structure, 8.80m x 3.80m internally, lies southeast – northwest on its long axis. The walls are of drystone construction, double faced with rubble infill, and are on average 0.80m thick with a maximum height of 1.50m, highest in the south. A doorway, 0.80m wide, is in the east corner and there may have been a window in the northwest wall. No internal features were visible but there is a considerable amount of stone tumble piled in the north corner of the structure. At the northeast end an arc of low walling defines an area 4.0m x 4.0m which is probably the bow ended remains of an earlier house which may have measured 13m x 3.80m, most of which lies under the present structure. A stretch of rough boulder walling 5.0m long adjoins the north corner. From the south corner a length of turf-covered walling, 0.80m wide, has some stone visible. This walling arcs round to join with Feature 16.

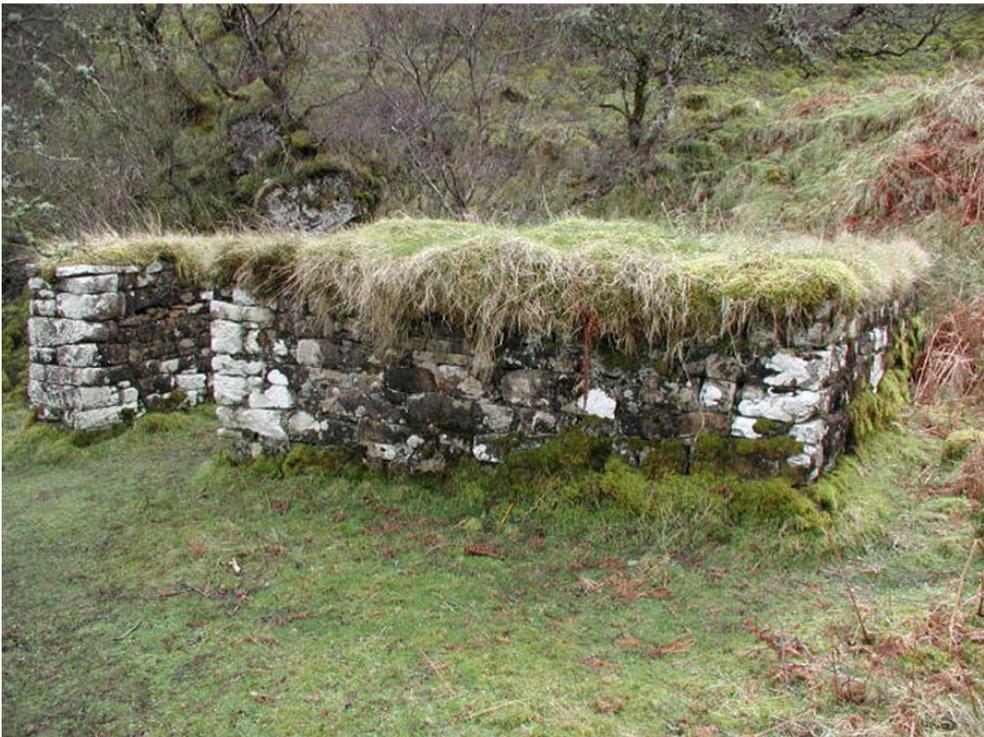
Feature 77 “The Pony Stable”

Feature 77**Stable****NG5964 3789 [100m OD]**

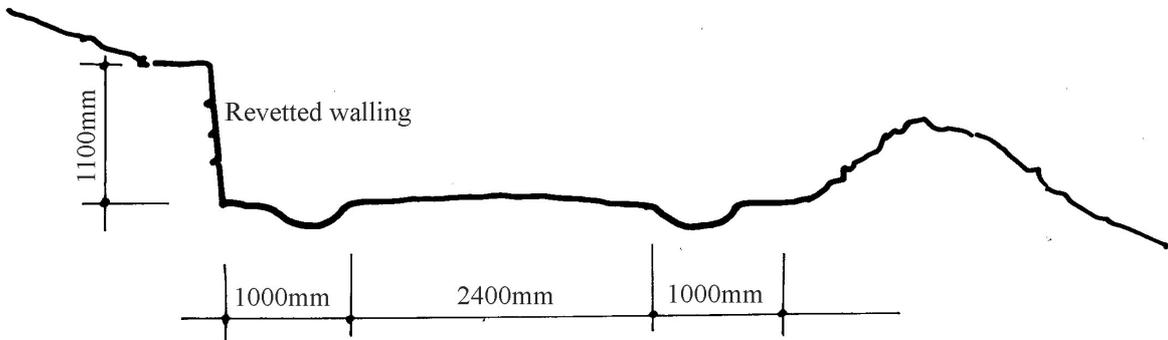
Details of the Track to Hallaig

Section across the Track
