# THE GROUNDS OF BANNOCKBURN HOUSE

Archaeological Survey by ACFA

June 2023

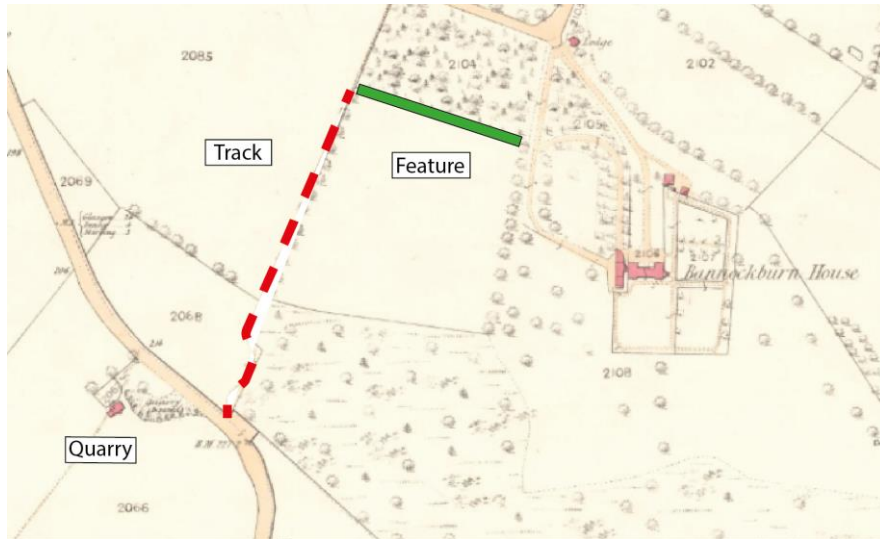
Figure 4: [OS First Edition Map \(1859\)](#)

The same feature can be seen on the OS map of 1859 (Figure 4) where it still divides the field but now ends at a small track rather than the road shown on Roy's map. The track, barely visible on the map, leads to a quarry which may be part of the remains of Coalheugh.

In Figure 4, the green line separates area number 2104 (north of the feature) from area 2108 (south). The land-use information, from the [OS Book of Reference](#) for the parish of St. Ninians (1862), tells us that area 2104 is a wood while 2108 is an area of arable farming and trees.

Although the feature looks like a field boundary which separates the two areas of land, this map together with Roy's map suggest that the feature may have formed part of a track which, by the 19<sup>th</sup> century (the date of the map in Figure 4), could be used as a short-cut from the back of the house to the major north-south road which passed near it.

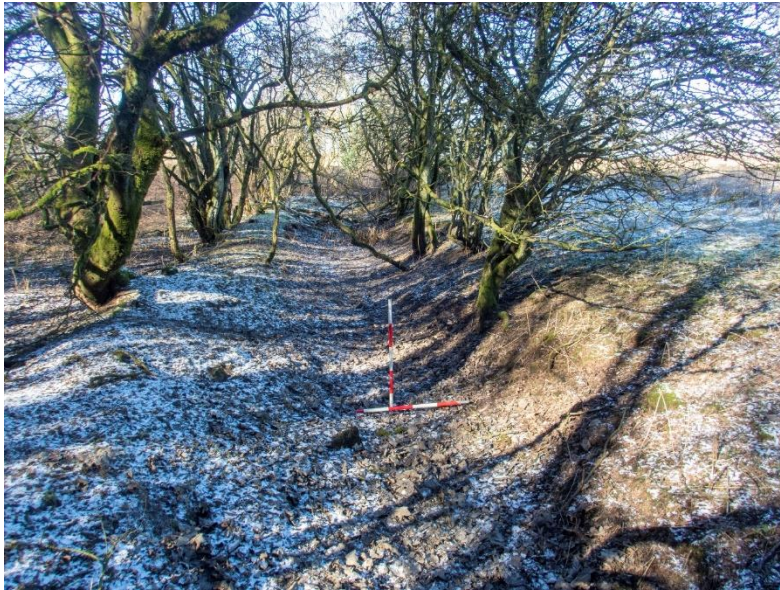
Although the feature looks like a field boundary on the early maps (Figure 3 and Figure 4), it does not look like a field boundary on the ground (Figure 6).

*Figure 6: Photograph of a cross-section of the feature.  
The camera is looking to the North-West, along the feature.*

In this photograph, the feature looks more like a track than a field boundary.

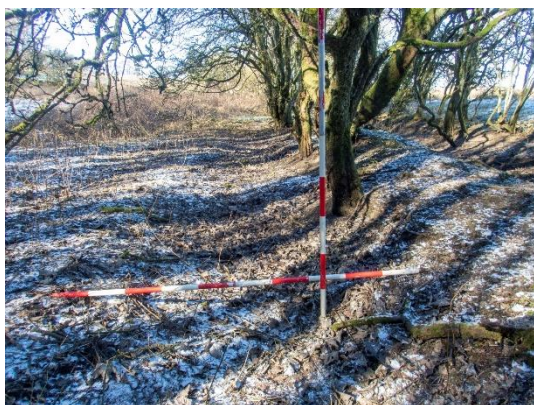
*Figure 9: Side Channel*

Photographs of the profile of the feature are shown in Figures 9 and 10. The camera was facing NW along the line of the feature, shown as a green line in Figure 7.

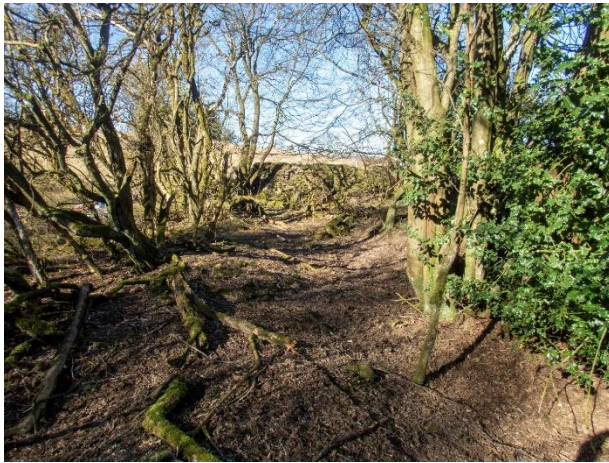
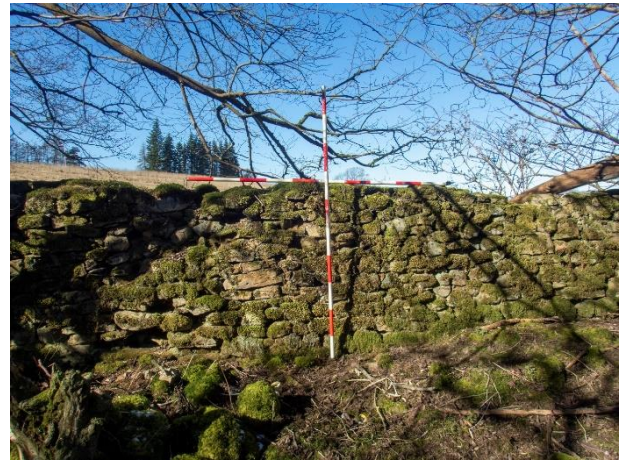
The wall at the end of the feature is shown in Figures 11 and 12. At this end of the feature, the main channel has almost disappeared while the side channel has completely vanished under the vegetation.

*Figure 11: Wall at end of feature*

*Figure 12: Wall at end of feature*

There was no sign that the feature continued beyond the wall. The survey team did not explore the area for traces of the track that can be seen on the 19<sup>th</sup> century map. It might be interesting to look for the remains of this track and to see whether it ever joined the feature.

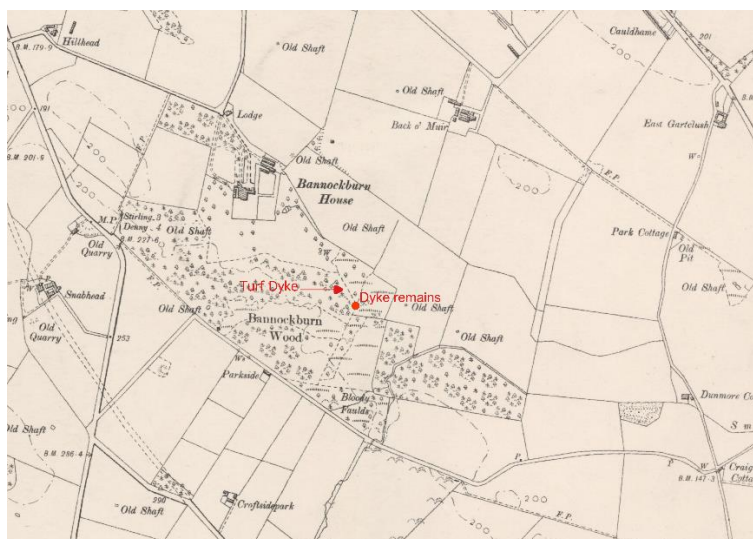
Figure 13: OS 2<sup>nd</sup> edition 6" map, [National Library of Scotland](#)

On the OS 2<sup>nd</sup> edition map (Figure 13) and the LiDAR image (Figure 14), a dot (labelled 'Dyke remains') marks the site of the survey team's drawing (Figure 17). An arrow indicates the location of the turf dyke, which is shown as a dotted line on the OS map. There is a faint line on the LiDAR, with rig and furrow to the west. Although the rig is clear on the LiDAR, it was not obvious to the team on the ground.

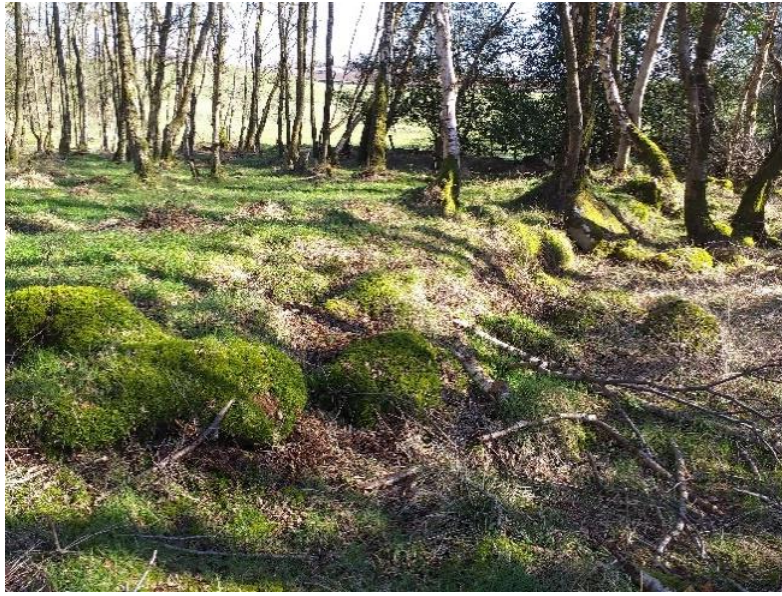
*Figure 15: Turf dyke*

The whole turf dyke as shown on the LiDAR was walked and traced on the ground (Figure 15). Interestingly, it is in a direct line to a modern fence. A 17.2m length of the dyke was exposed to its stone footings (Figure 16). No sign of the dyke continuing was found downhill from the exposed section, but it was noted that the trees respected the projected line of the wall with dense woodland to the east.
