An Archaeological Survey
of the townships of Oskaig and Holoman
and a field survey of the surrounding area.

Raasay

Portree Parish
Skye and Lochalsh District, Highland Region

Association of Certificated Field Archaeologists
(Glasgow University)
Occasional Paper No. 13

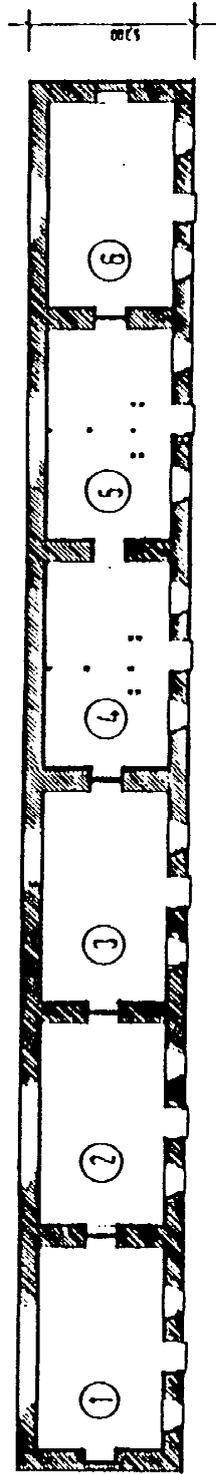
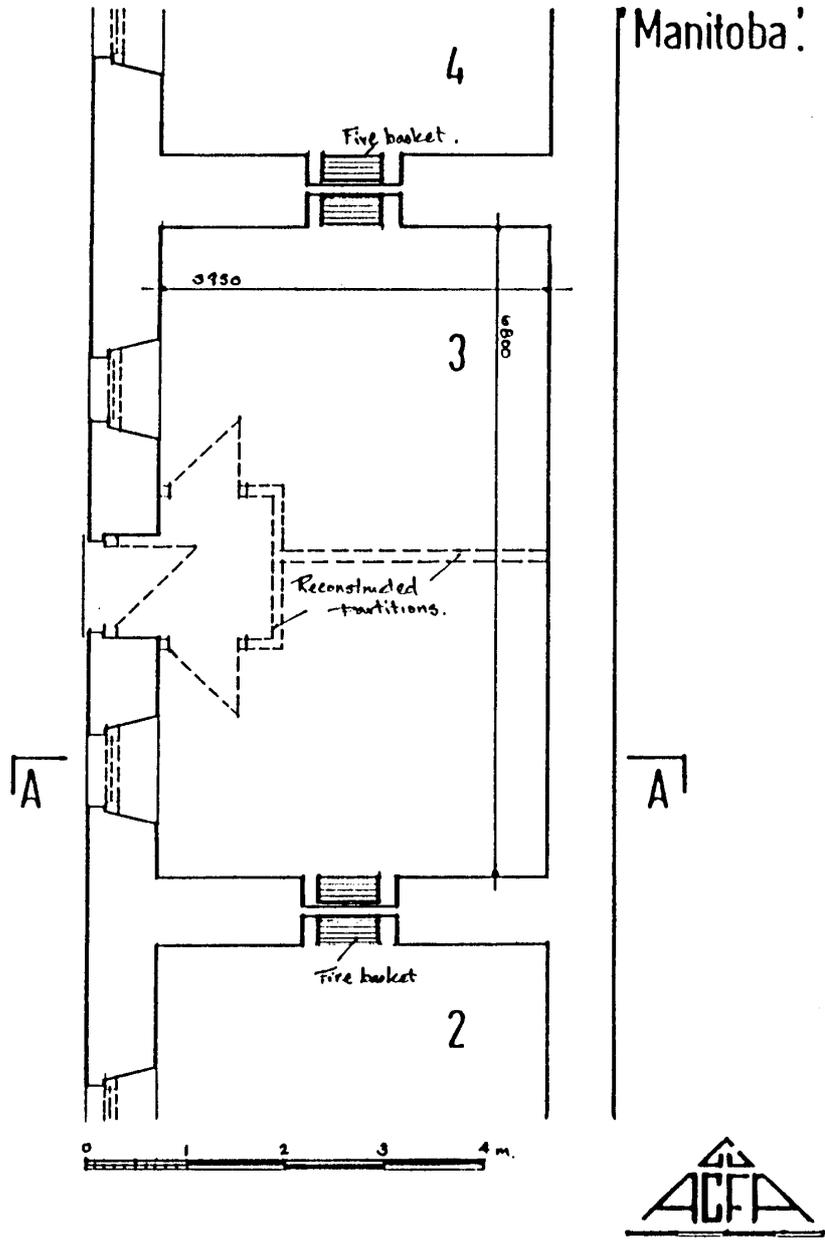
Feature 12

At the Northern extremity of Oskaig on land falling gently northwards to the sea lies a substantial and impressive ruin known as Manitoba.

The stonebuilt terrace of six houses lies on an east to West axis with doors and windows only in the South elevation. the structure is 46m long X 5.3m wide built with mortared stonework. The Eastern gable is almost intact at a height of 3.45m while the Western one is ruinous at barely 1m high. The North wall, apart for some 7m at the West, is also largely intact at a height of 2m. The South front is pierced by six doors and twelve window openings; a door with a window on either side serving each of the six dwellings. The wall head course and the lintels are mostly missing. the dwellings are separated by stone built mutual walls with back to back fireplaces and flues within the wall thickness. All walls including the gables are 0.7m thick.

Each house unit is 6.8m long X 3.9m wide. A series of 75mm square sockets cast into the concrete floor slab indicate a small hallway behind the door with a room on each side; the room to the West around 300mm larger than that on the East. The fire opening in each room is 0.9m wide X 0.3m deep X 0.95m high and separated from that in the adjoining house by 0.10m thick stone work. The openings each have large stone lintels 0.35m high X 0.10m thick behind which the flues are quickly tapered to 0.3m square. Above the lintel a 12mm diameter steel bar is set across the flue for hanging utensils over the fire basket still in situ in a number of instances.

The door openings are 0.9m wide at the exterior with 0.15m reveals and 0.05m checks. The door jambs are splayed to give an internal opening width of 1.05m.

No evidence of a roof remains but it is reported that the structure was of timber trusses with purlins clad with corrugated iron sheeting. It is believed that the range of houses was built in 1889 for widows and paupers. The name Manitoba is said to have been coined from a remark questioning why people should wish to go to Canada when such fine facilities were available on Raasay.

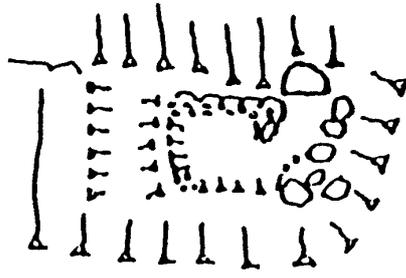
Feature 27

A small subrectangular structure 5m X 3m. It is built on a small area of comparatively flat ground and is constructed of dry stone walling on its downslope side and is cut into the hill slope at the rear. At its South side there is a low stone and turf bank and at its North side a number of large boulders. A possible entrance lies in its West wall. Its interior is covered in tumble. It has been used for a number of different purposes over the years but the most recent was described as a hen house.

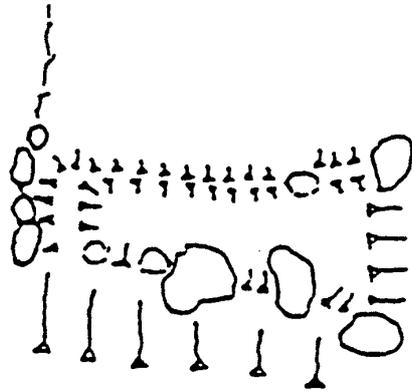
Feature 28

Lying to the North and upslope from structure 27 are the remains of a small subrectangular enclosure. It measures 8m X 4m, is constructed on its upslope side by large boulders and is partly dug into the hillside. The rest of the structure comprises a low stone and turf bank. There is a possible entrance at its North East end.

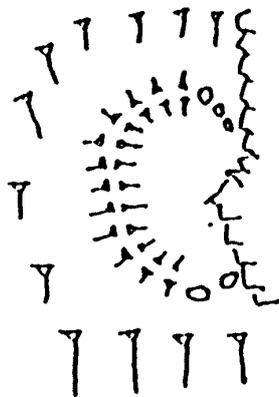
Feature 29

Lying to the North and downslope at a distance of 6m from 28 is a small semi-circular enclosure or shelter. It is built against the side of a rock face and on its remaining sides it is constructed from a low stone and turf bank. It measures 7m X 4m with a possible entrance on its downslope side.

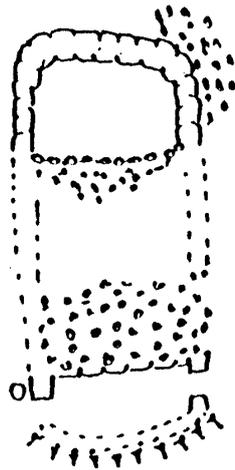
Feature 4

Feature 4. NG 55204006 Originally a house, the feature is sub rectangular and measures 11 m x 6m. It has rounded corners at its north end and square corners at the south end. However, it has additional curved waiting at its south end lying 2.5m from the gable. The probability is that the house was originally longer with rounded comers at both ends. The walls are of drystone construction with an inner and outer facing and rubble infill. The walls are approximately 0.8m thick. There is evidence of an entrance in the east wall. At its north end the wall survives to a height of 1 m. At 2.5m from the inner face of the north gable is a cross wall, probably recent, to form a sheep shelter. At the south end is a considerable amount of rubble.

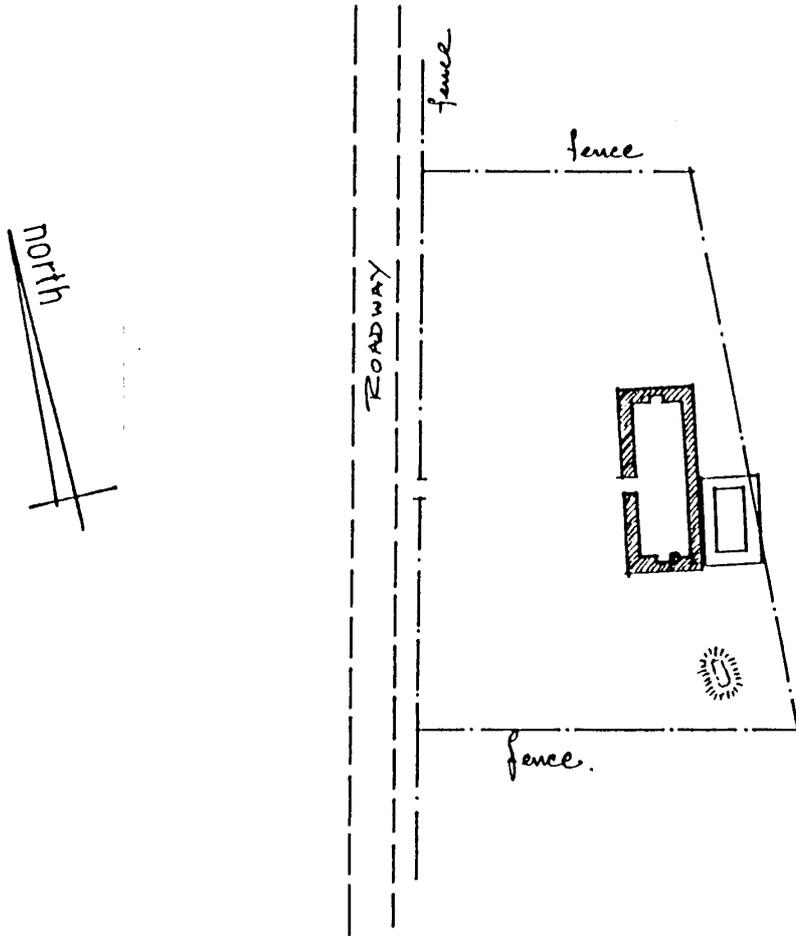
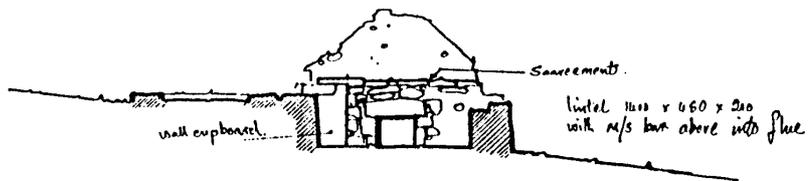
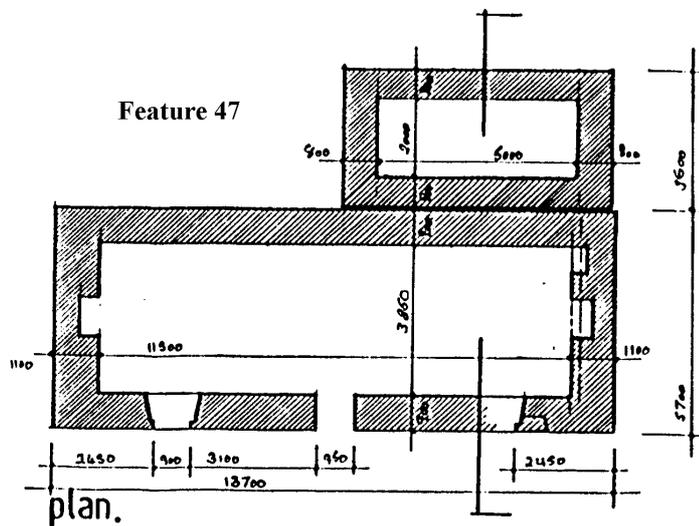
Holoman cottage

It is known that the house has been empty since the first years of this century and that it was the home of a Miss Kate McLean, daughter of William McLean mentioned as leveling the road from Raasay House to the shore in the Raasay House Weather Diaries 15/3/1852.
